ASBESTOS INSPECTION REPORT

Project Location: Delores Town Hall Building 420 Central Avenue Dolores, Colorado 81323

> September 29, 2023 Project No. AS23127

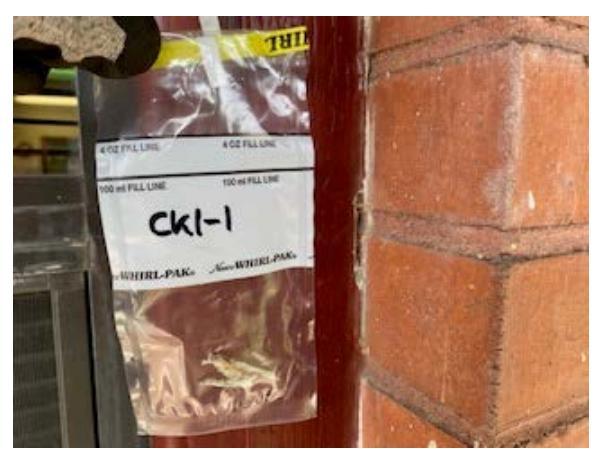
Sample: CLK1-1 Result: 37% Chrysotile

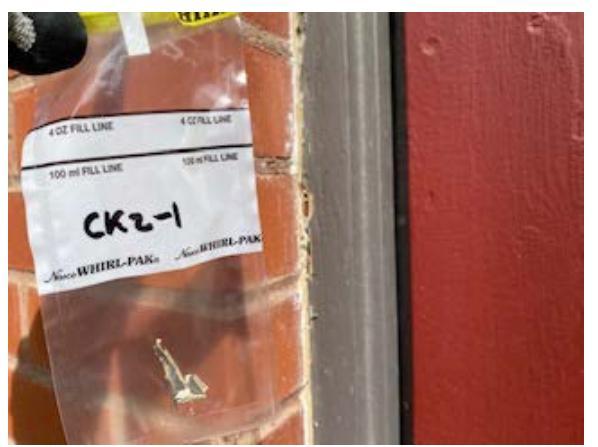
Sample: CLK2-1 Result: 8% Chrysotile

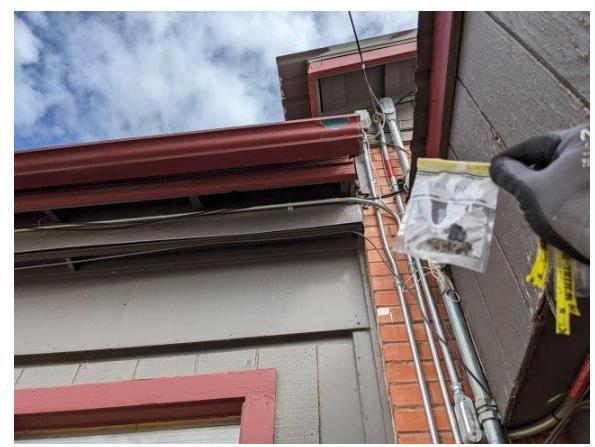
Sample: RRT1-1 Result: 4% Chrysotile

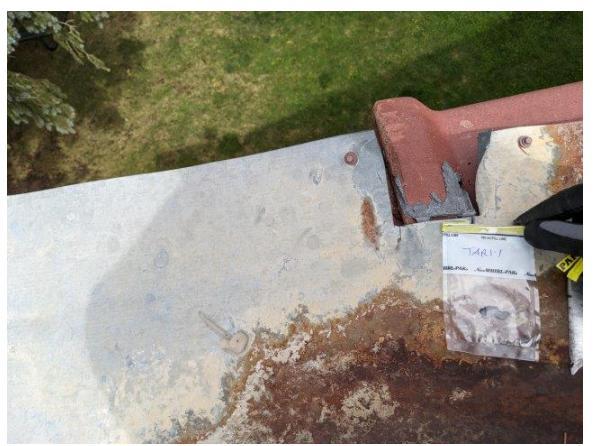
Sample: TAR1-1 Result: 11% Chrysotile

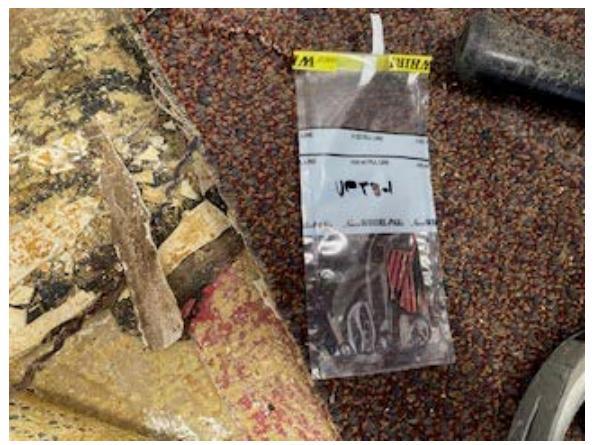
Sample: VFT3-1 Result: 7% Chrysotile in floor tile Mastic was non-detect

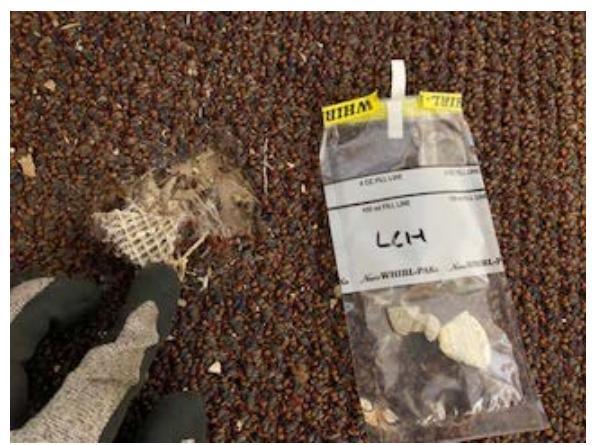
Sample: LC1-1 Result: 9% Chrysotile in floor tile Leveling compound was non-detect

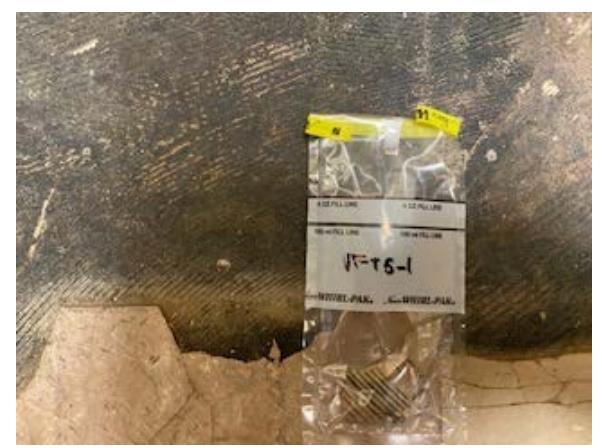
Sample: VFT5-1 Result: 12% Chrysotile in floor tile Mastic was non-detect

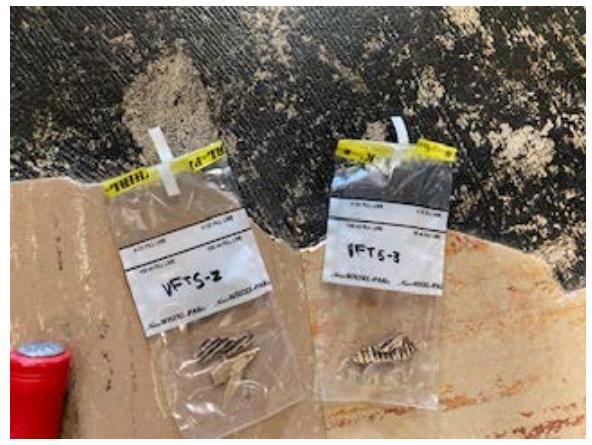
Sample: VFT5-2/3 Result: 12% Chrysotile in floor tile Mastic was non-detect

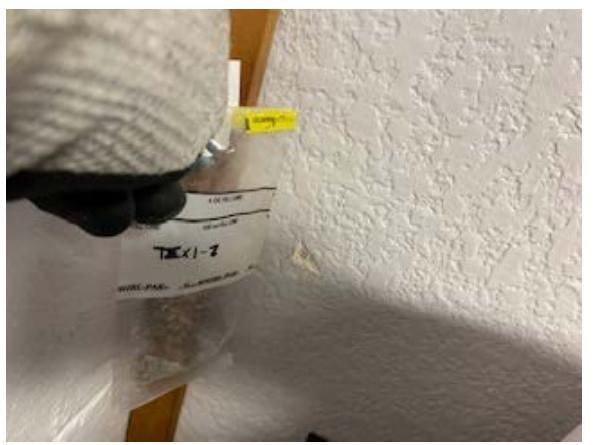
Sample: TEX1-2 Result: 3% Chrysotile in off-white compound Texture was non-detect

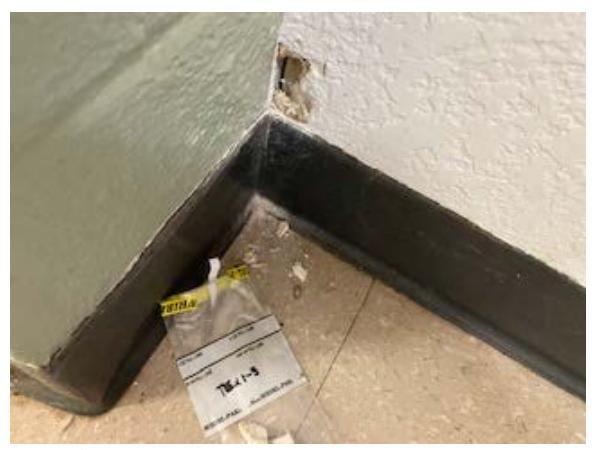
Sample: TEX1-3 Result: 3% Chrysotile in off-white compound Texture was non-detect

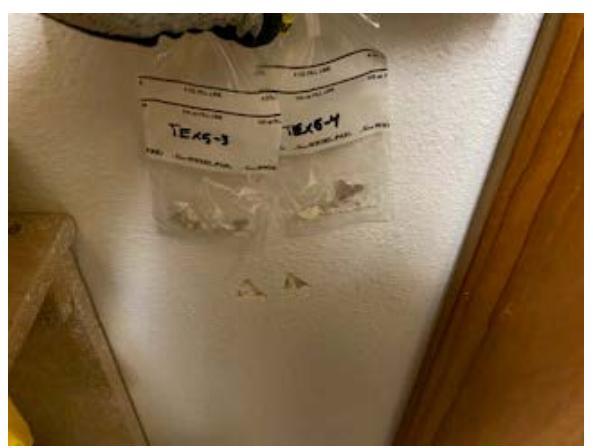
Sample: TEX5-3/4 Result: 3% Chrysotile in off-white compound Texture was non-detect

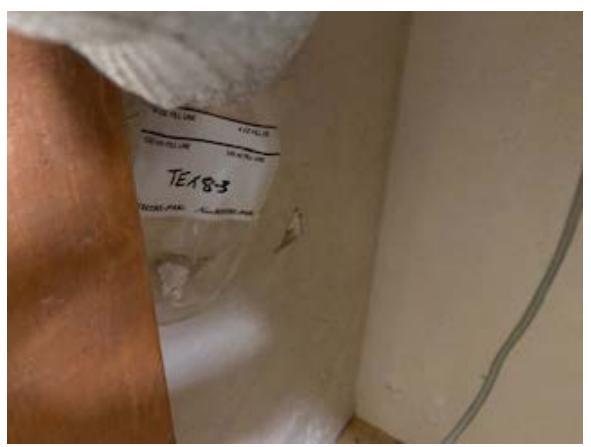
Sample: TEX8-3 Result: 2% Chrysotile in off-white compound Texture was non-detect

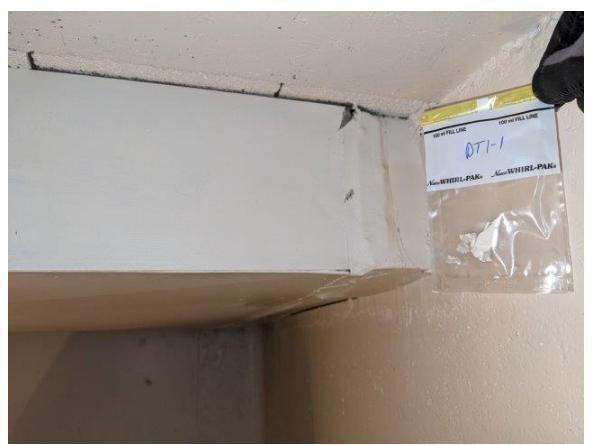
Sample: DT1-1 Result: 55% Chrysotile

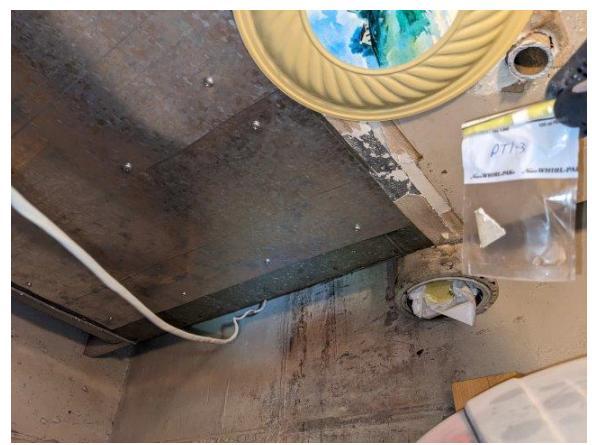
Sample: DT1-3 Result: 65% Chrysotile

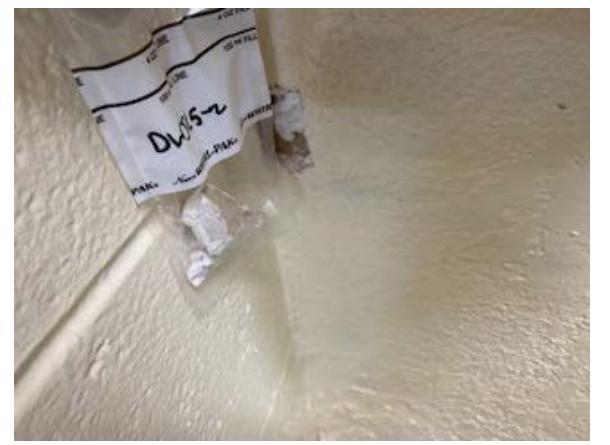
Sample: DWJC5-2 Result: 2% Chrysotile in off-white compound
