ASBESTOS INSPECTION REPORT

Project Location: Delores Town Hall Building 420 Central Avenue Dolores, Colorado 81323

> September 29, 2023 Project No. AS23127

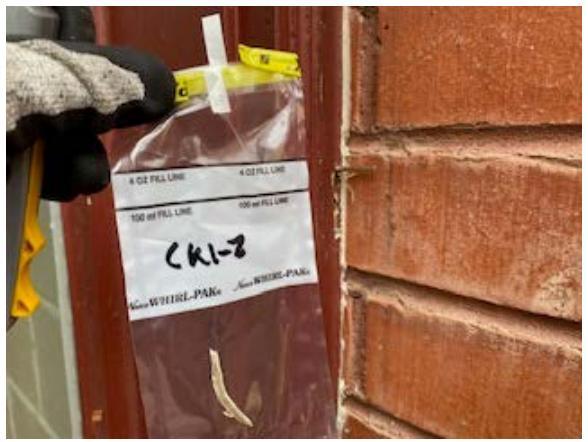
Sample: CLK1-2 Result: 32% Chrysotile

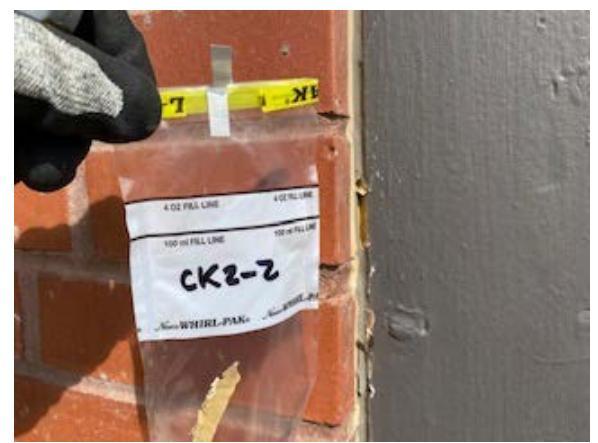
Sample: CLK2-2 Result: None Detected

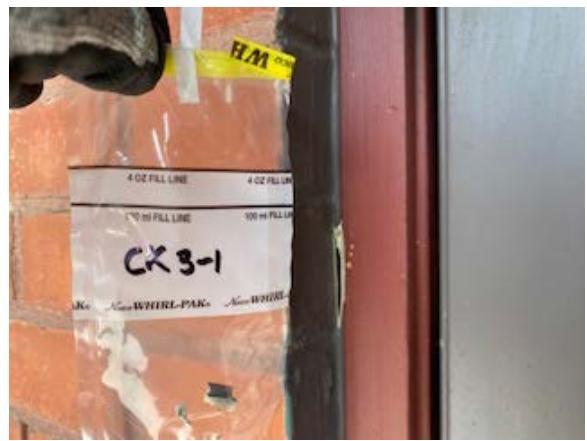
Sample: CLK3-1 Result: None Detected

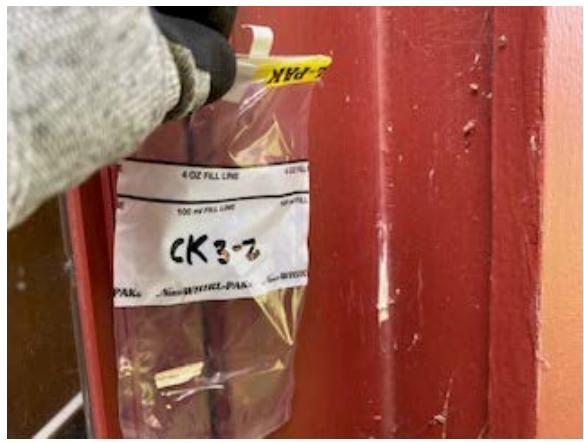
Sample: CLK3-2 Result: None Detected

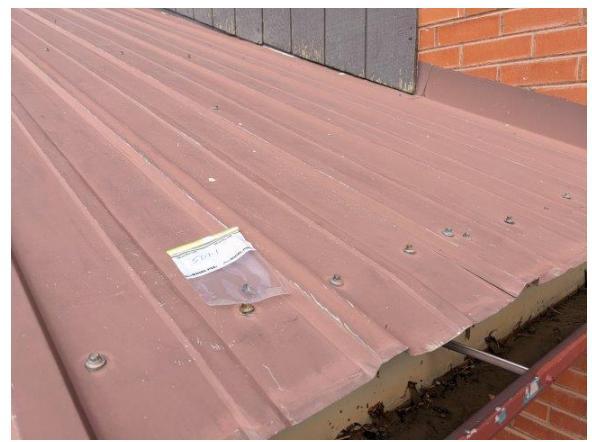
Sample: SG1-1 Result: None Detected

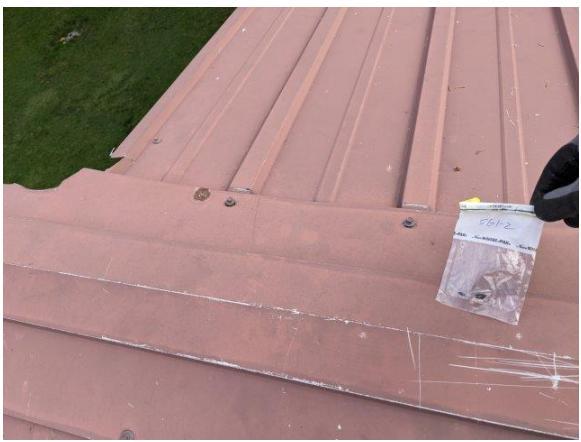
Sample: SG1-2 Result: None Detected

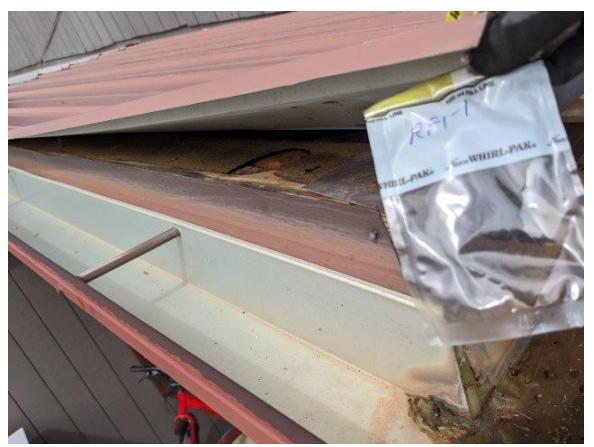
Sample: RF1-1 Result: None Detected

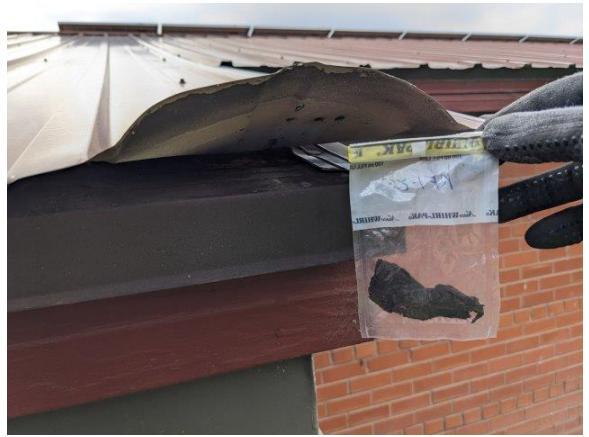
Sample: RF1-2 Result: None Detected

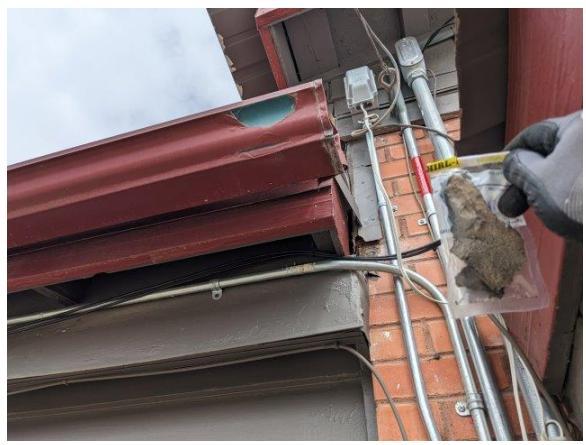
Sample: RRT1-2 Result: 4% Chrysotile in paint 6% Chrysotile in tar

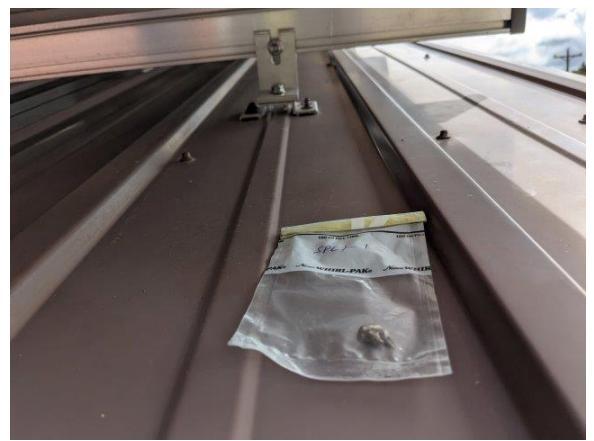
Sample: SPC1-1 Result: None Detected

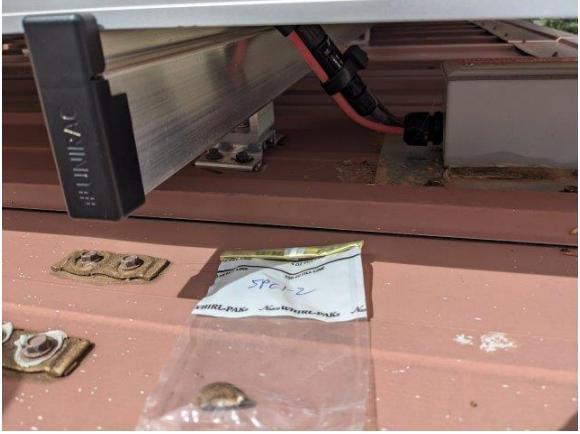
Sample: SPC1-2 Result: None Detected

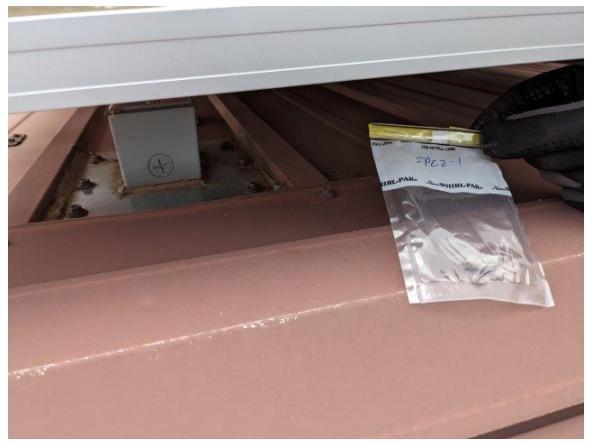
Sample: SPC2-1 Result: None Detected

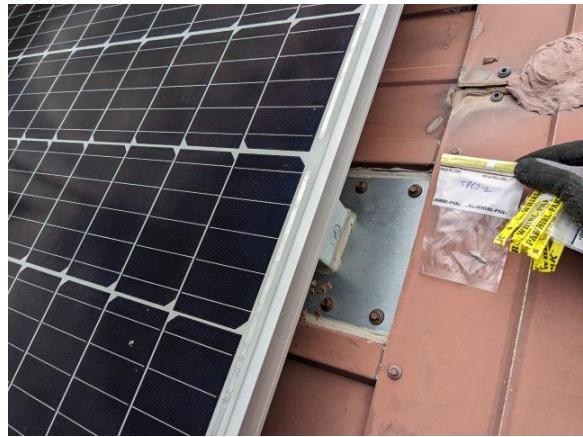
Sample: SPC2-2 Result: None Detected

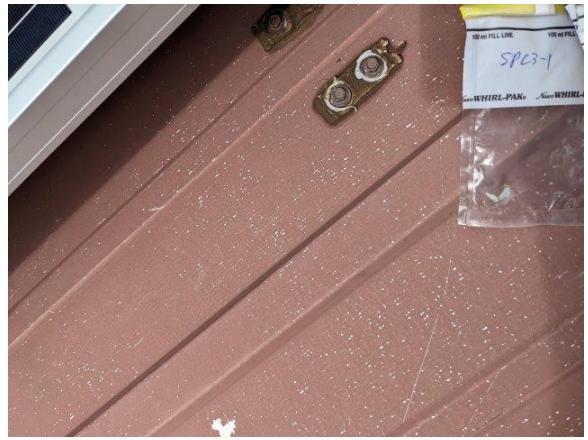
Sample: SPC3-1 Result: None Detected

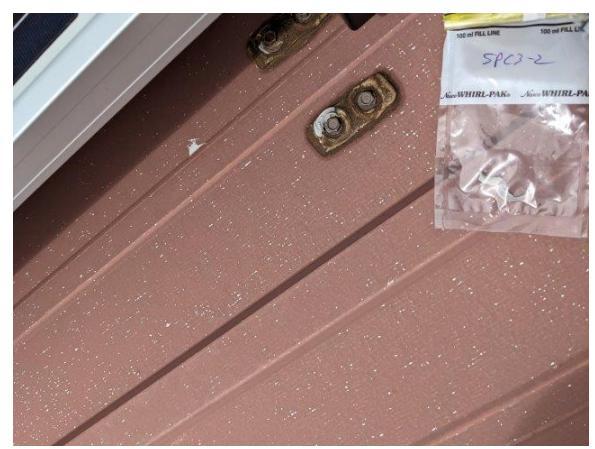
Sample: SPC3-2 Result: None Detected

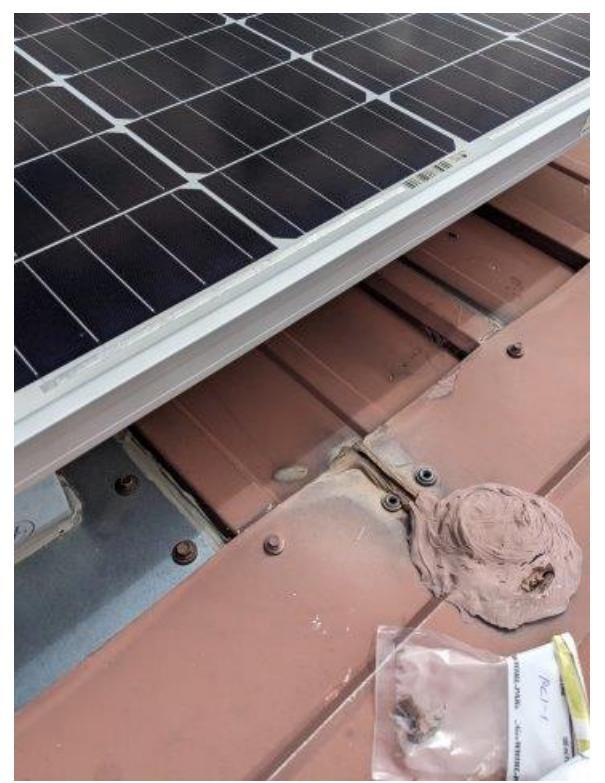
Sample: RC1-1 Result: None Detected

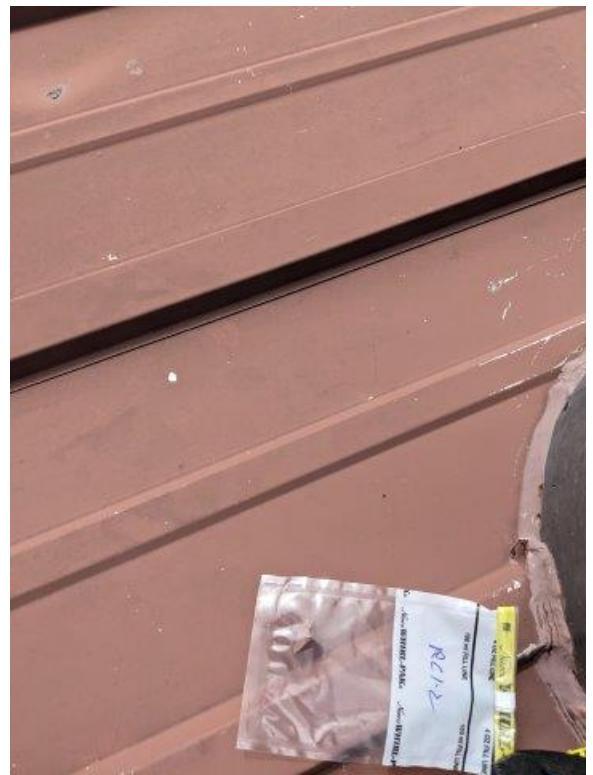
Sample: RC1-2 Result: None Detected

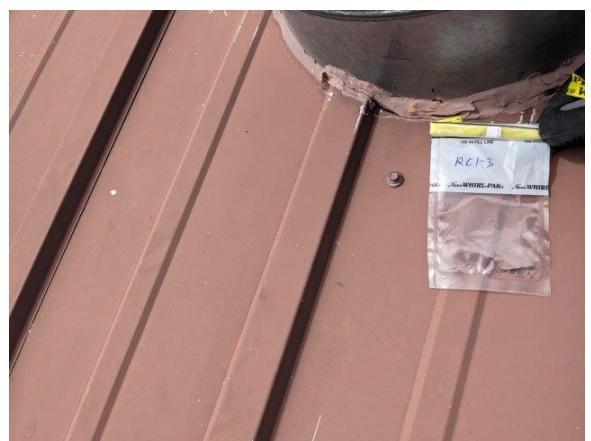
Sample: RC1-3 Result: None Detected

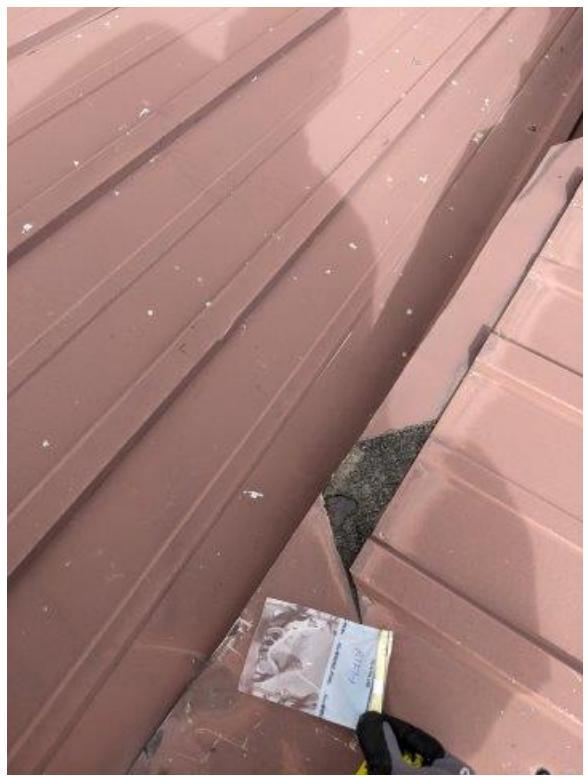
Sample: RTF1-1 Result: None Detected

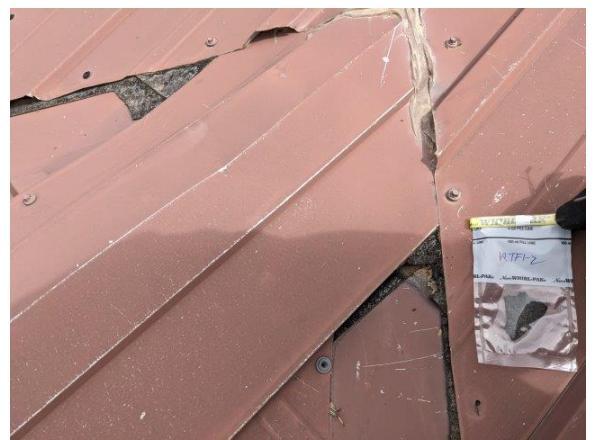
Sample: RTF1-2 Result: None Detected

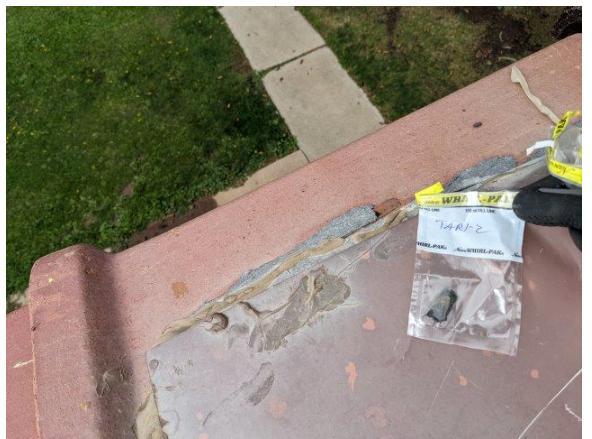
Sample: TAR1-2 Result: 12% Chrysotile

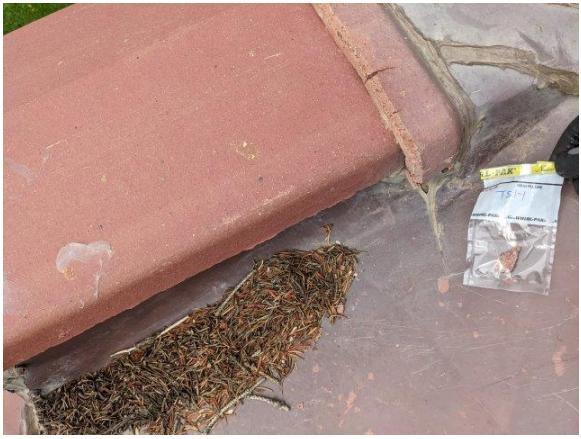
Sample: TS1-1 Result: None Detected

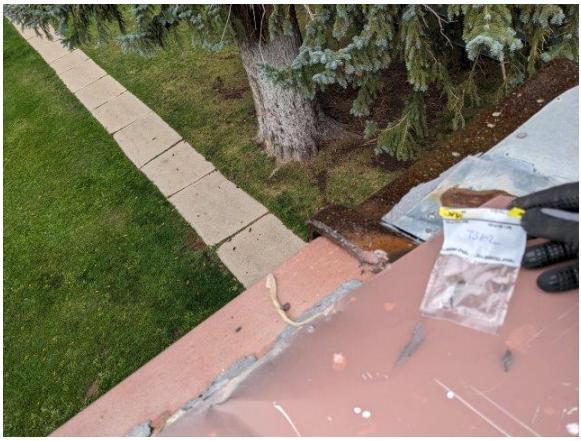
Sample: TS1-2 Result: None Detected

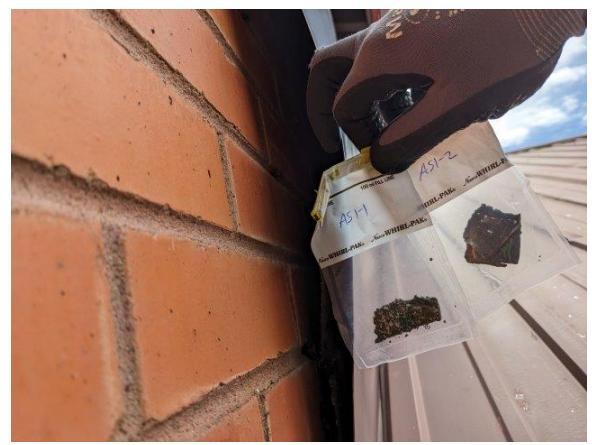
Sample: AS1-1/2 Result: None Detected

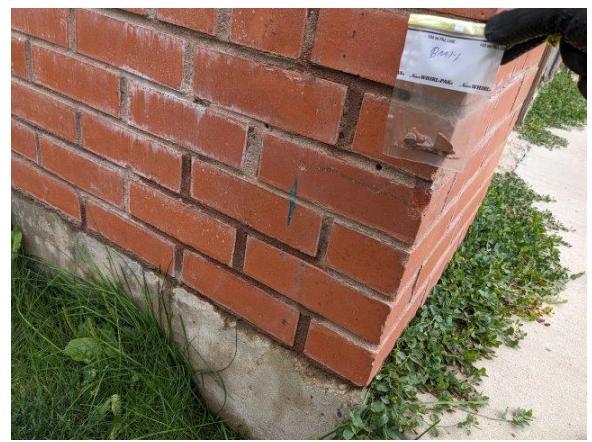
Sample: BM1-1 Result: None Detected

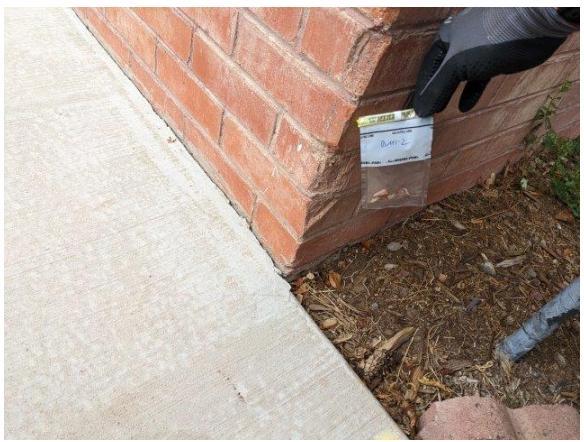
Sample: BM1-2 Result: None Detected

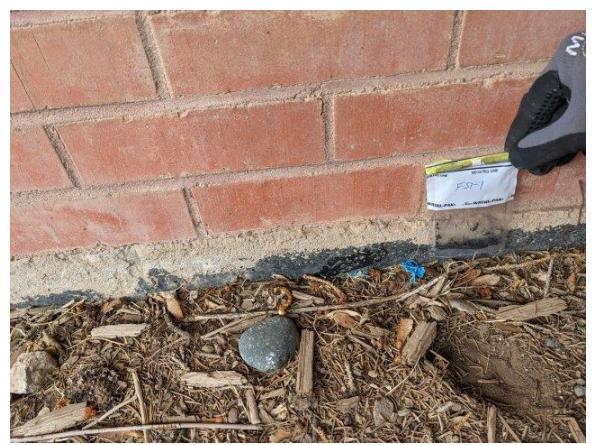
Sample: FS1-1 Result: None Detected

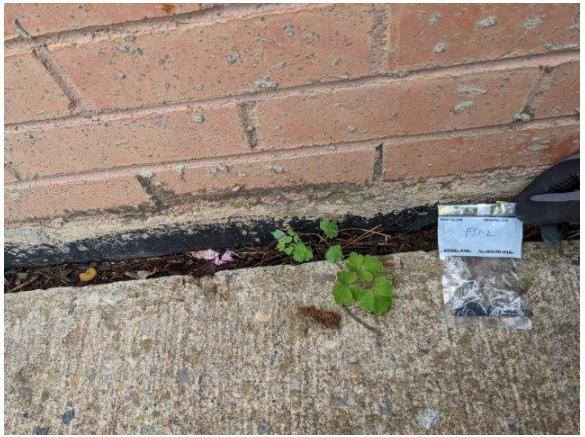
Sample: FS1-2 Result: None Detected

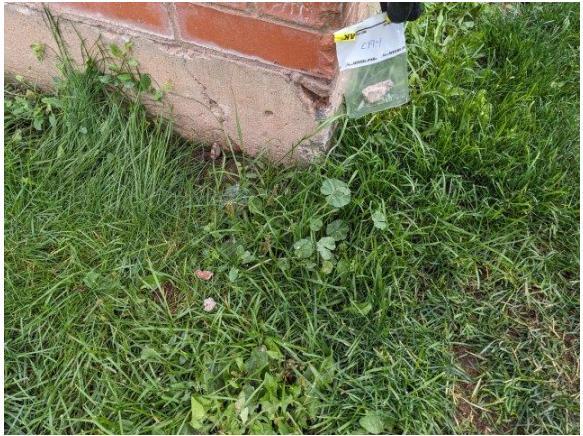
Sample: CF1-1 Result: None Detected

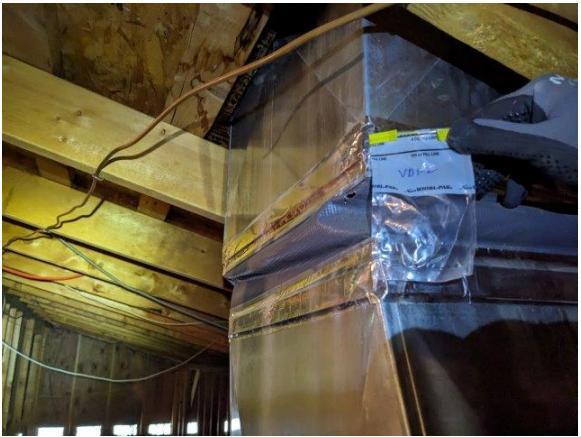
Sample: VD1-1 Result: None Detected

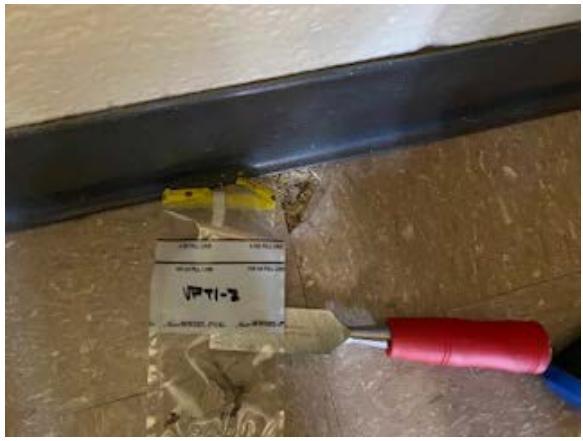
Sample: VFT1-1 Result: None Detected

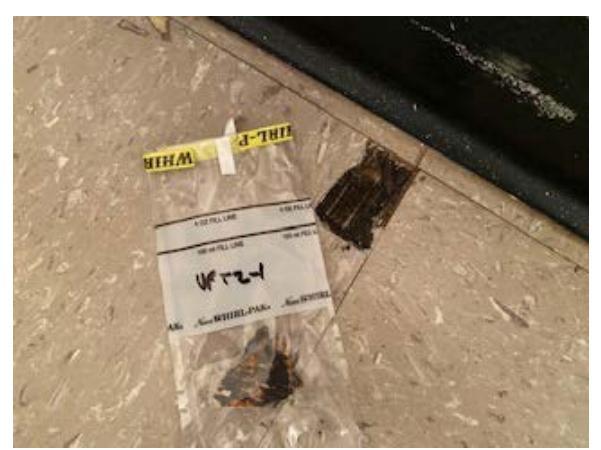
Sample: VFT1-2 Result: None Detected

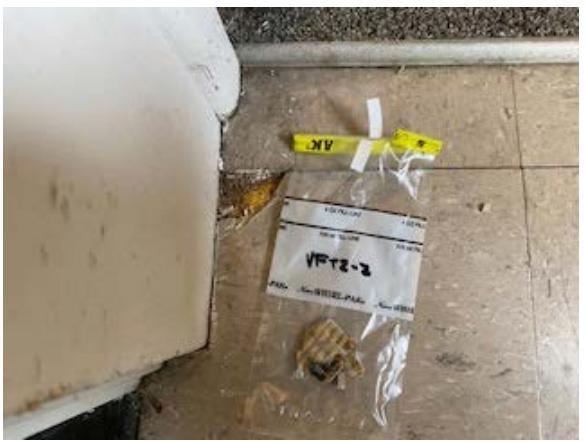
Sample: VFT2-1 Result: None Detected

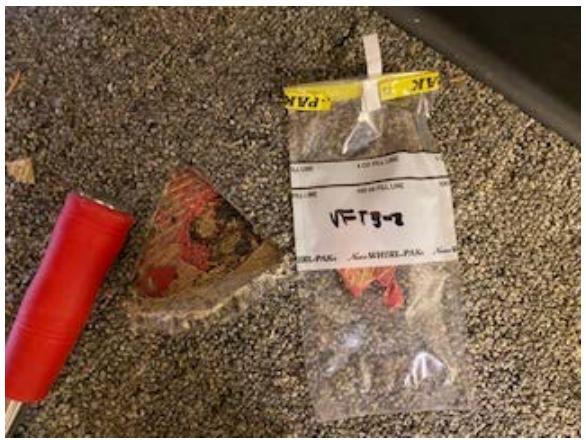
Sample: VFT3-1 Result: 7% Chrysotile in floor tile Mastic was non-detect

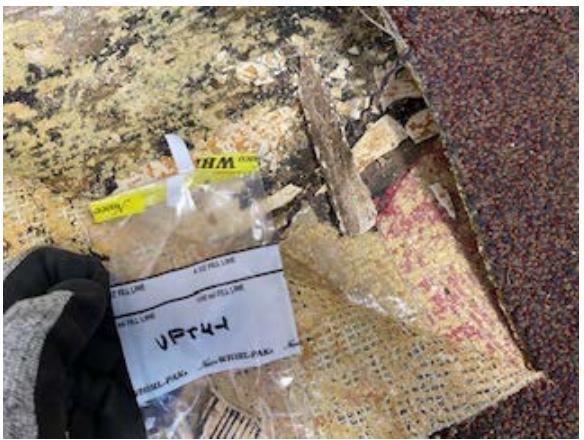
Sample: VFT3-2 Result: 7% Chrysotile in floor tile Mastic was non-detect

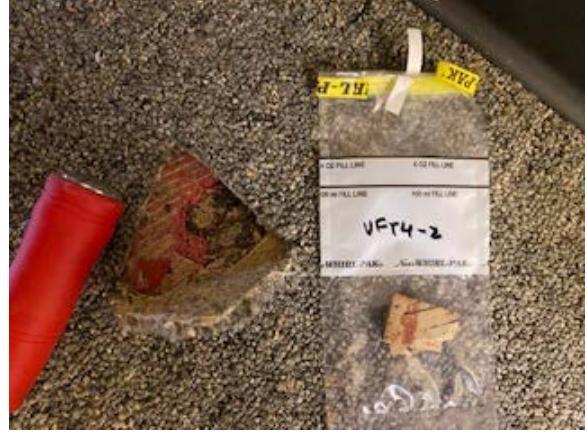
Sample: VFT4-1 Result: 12% Chrysotile in floor tile Mastic was non-detect

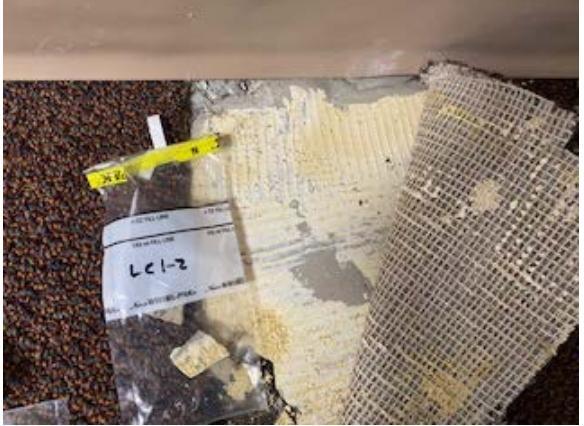
Sample: LC1-1 Result: 9% Chrysotile in floor tile Leveling compound was non-detect

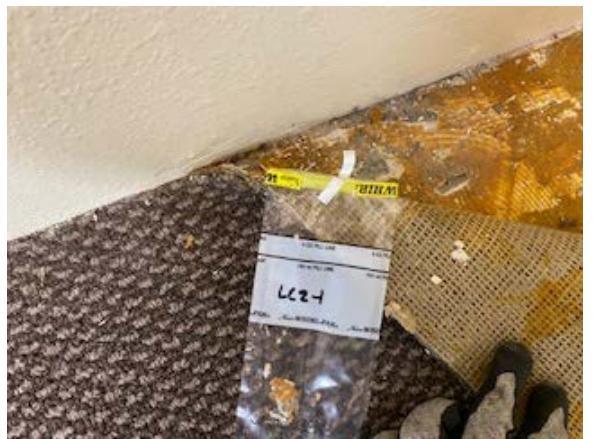
Sample: LC1-2 Result: 5% Chrysotile in floor tile Leveling compound was non-detect

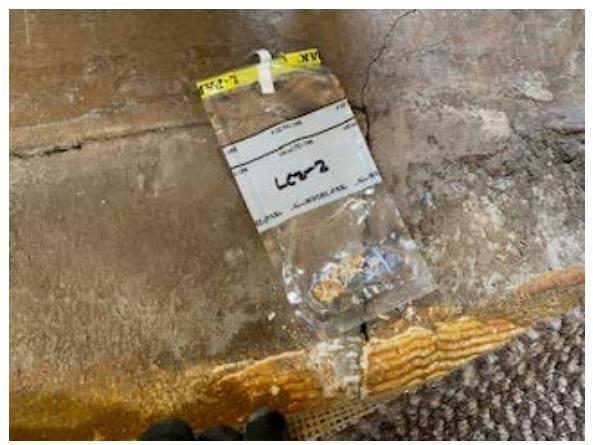
Sample: LC2-1 Result: None Detected

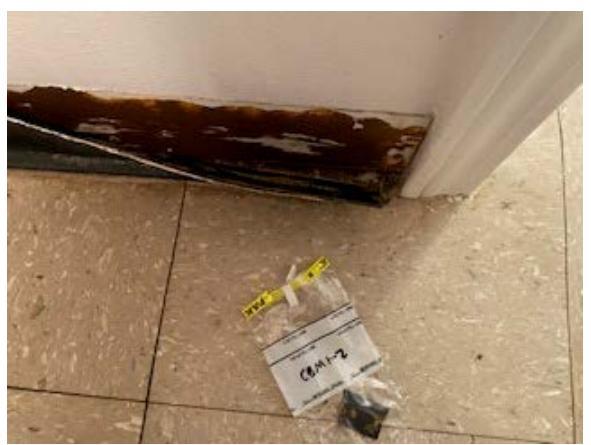
Sample: CBM1-1 Result: None Detected

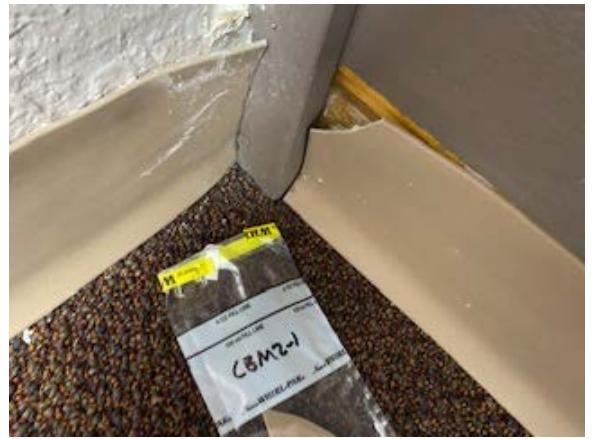
Sample: CBM1-2 Result: None Detected

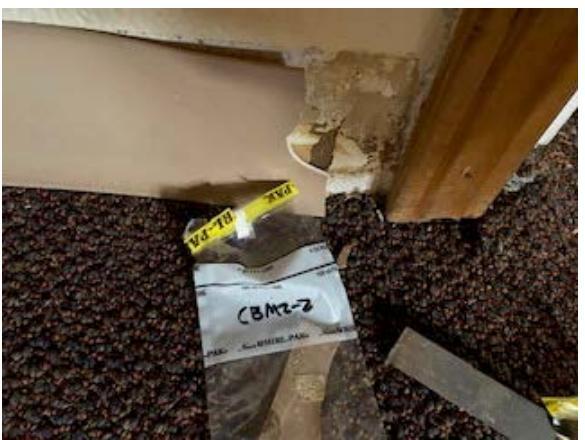
Sample: CBM2-1 Result: None Detected

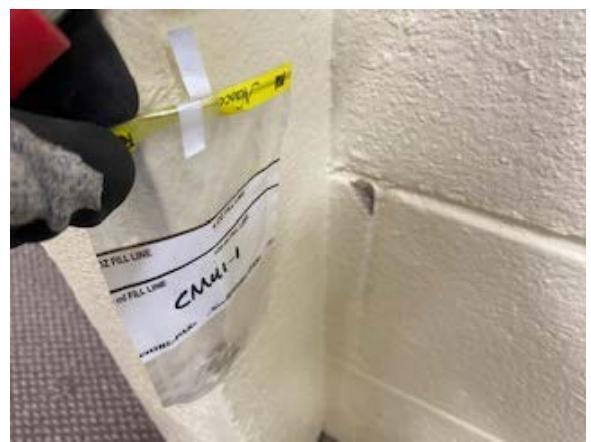
Sample: CBM2-2 Result: None Detected

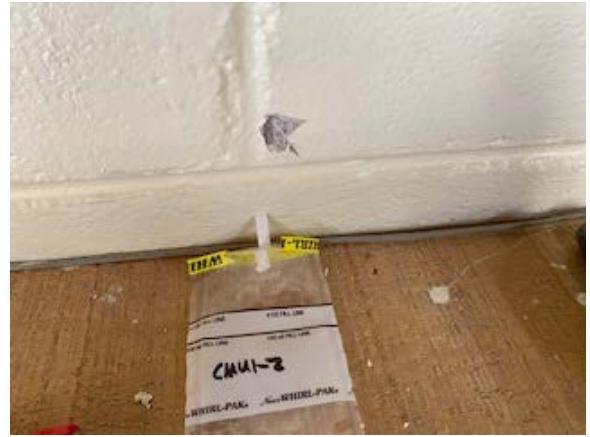
Sample: CMU1-1 Result: 2% Chrysotile in granular material

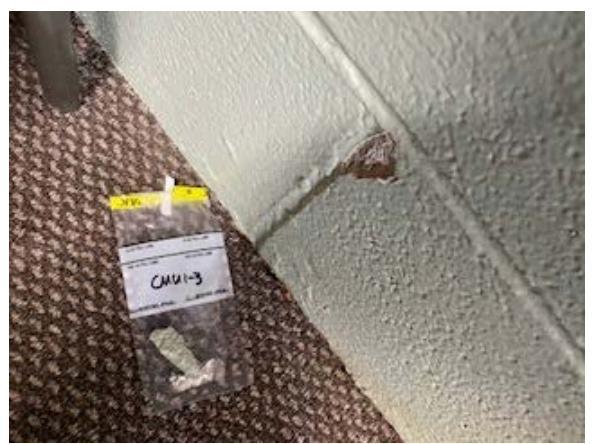
Sample: CMU1-2 Result: 2% Chrysotile in granular material

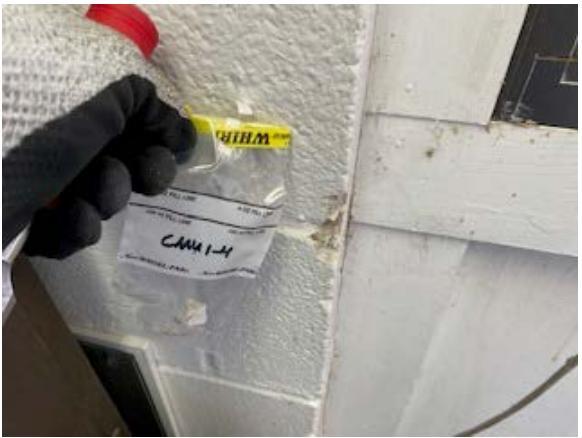
Sample: CMU1-3 Result: 'Trace' Chrysotile in block filler

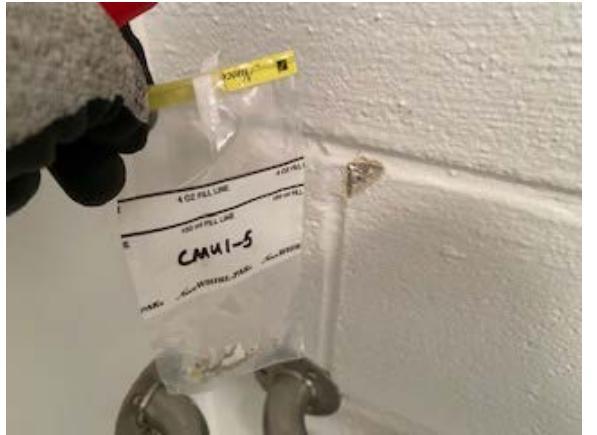
Sample: CMU1-4 Result: 'Trace' Chrysotile in block filler

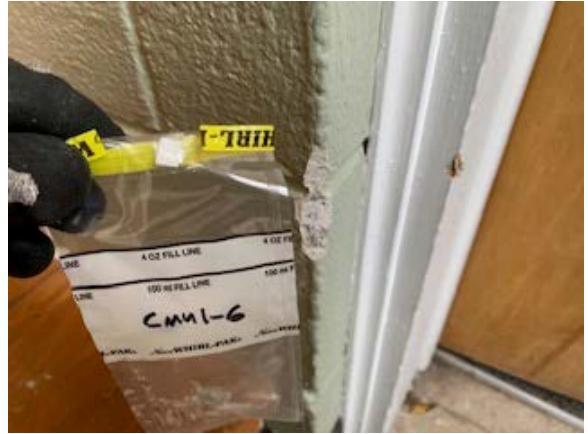
Sample: CMU1-5 Result: 'Trace' Chrysotile in block filler

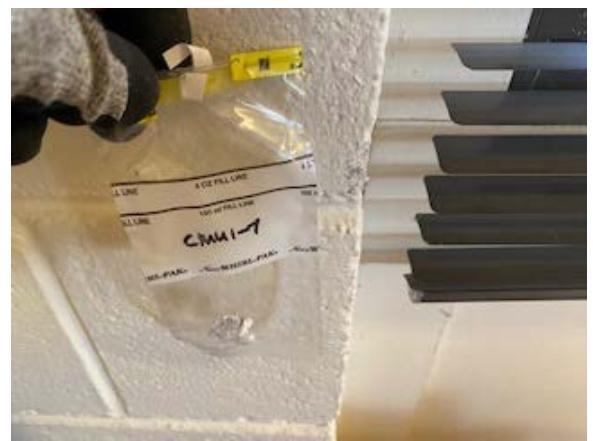
Sample: CMU1-6 Result: 'Trace' Chrysotile in block filler

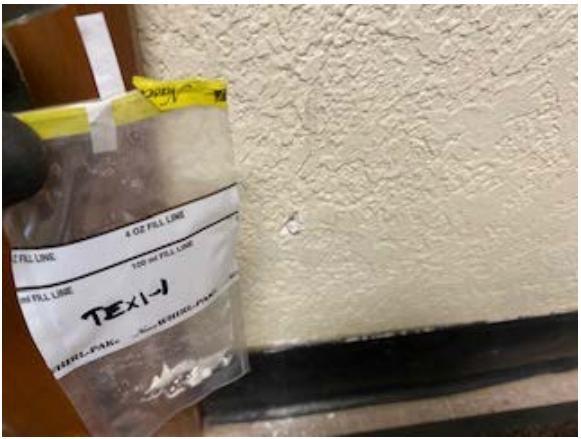
Sample: TEX1-1 Result: None Detected

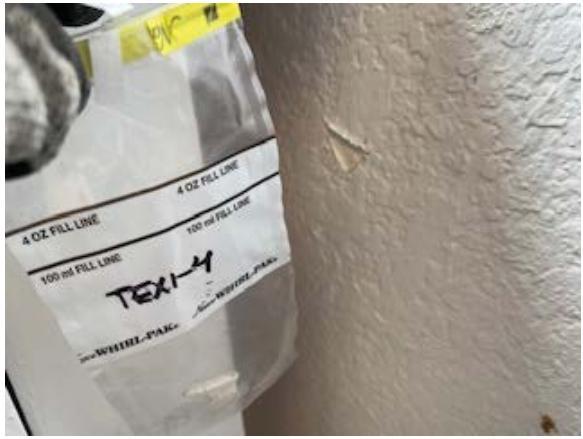
Sample: TEX1-4 Result: None Detected

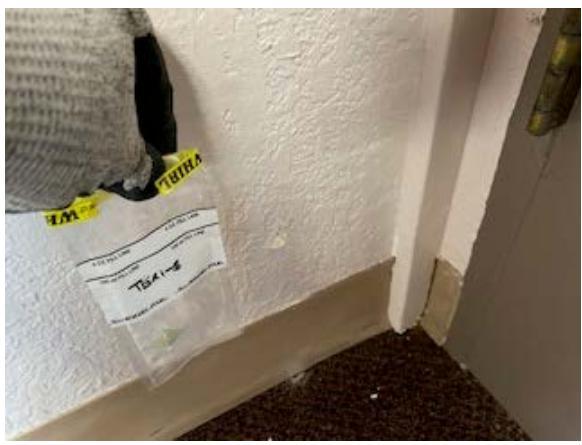
Sample: TEX1-5 Result: None Detected

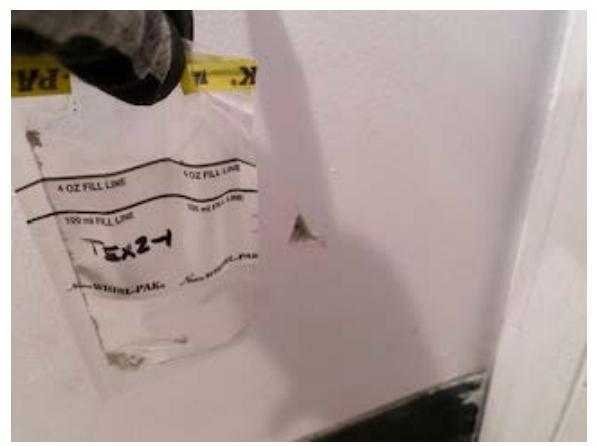
Sample: TEX2-1 Result: None Detected

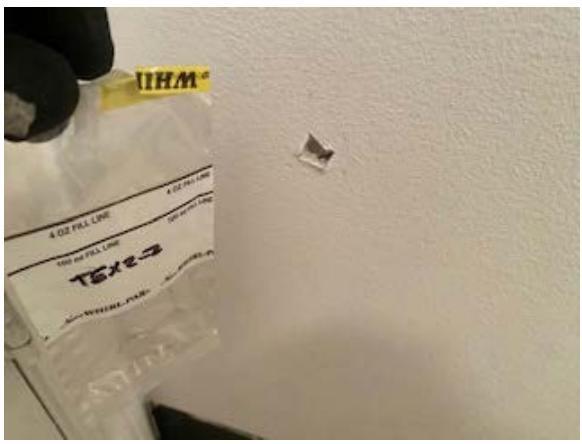
Sample: TEX2-2 Result: None Detected

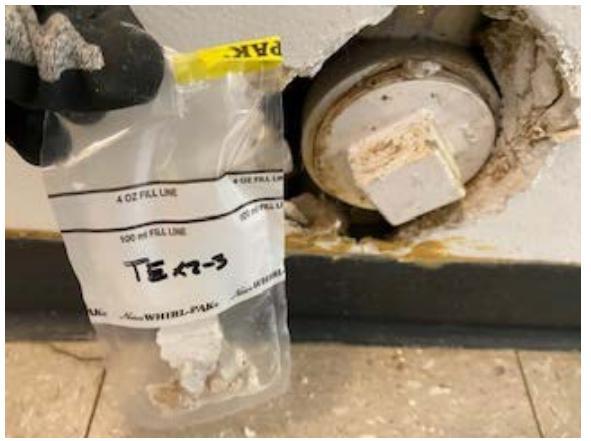
Sample: TEX2-3 Result: None Detected

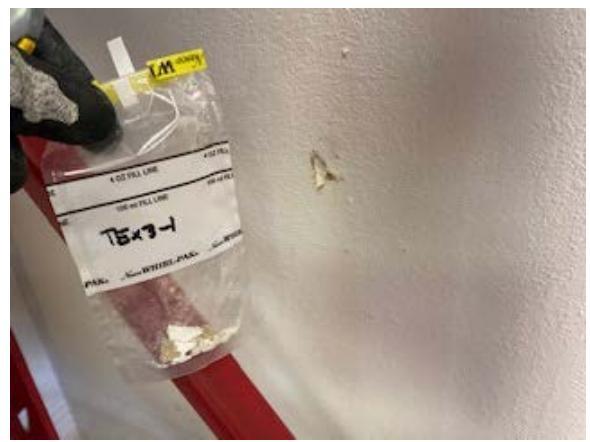
Sample: TEX3-1 Result: None Detected

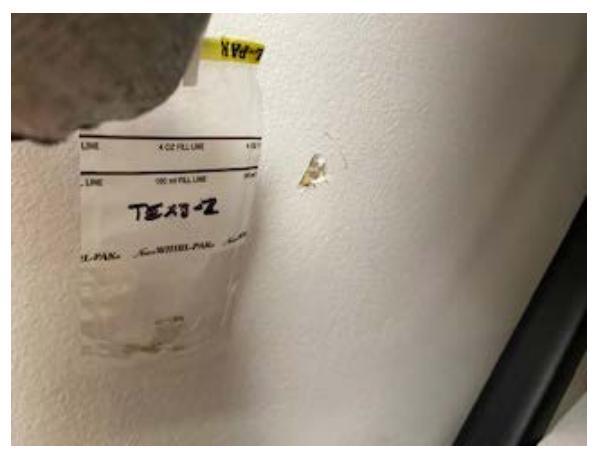
Sample: TEX3-2 Result: None Detected

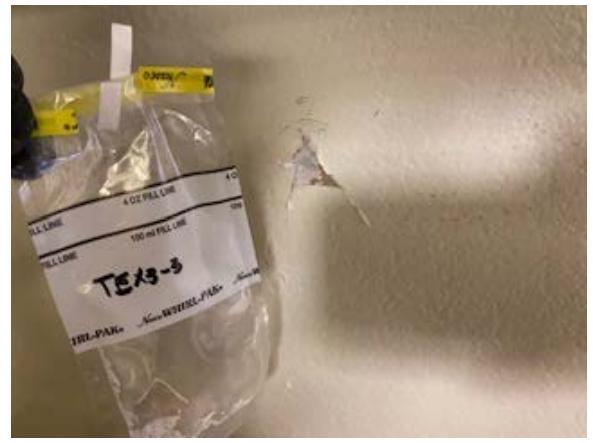
Sample: TEX3-3 Result: None Detected

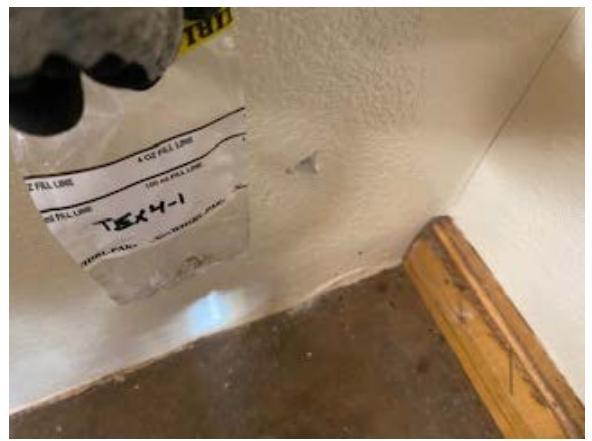
Sample: TEX4-1 Result: None Detected

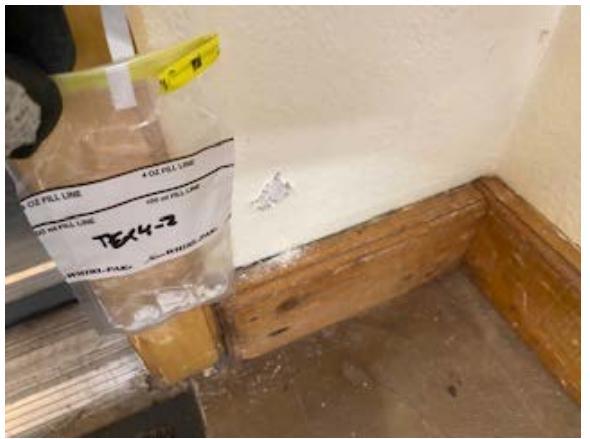
Sample: TEX4-2 Result: None Detected

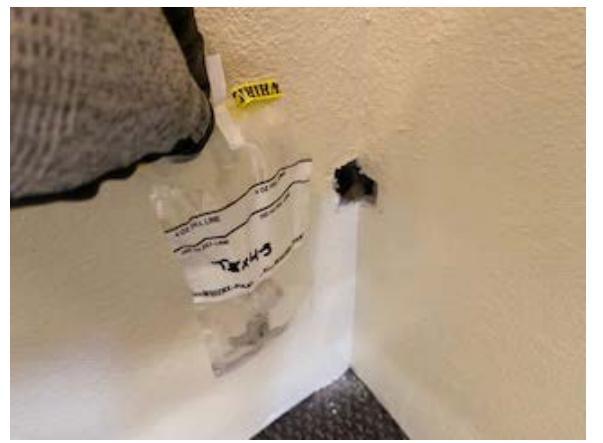
Sample: TEX4-3 Result: None Detected

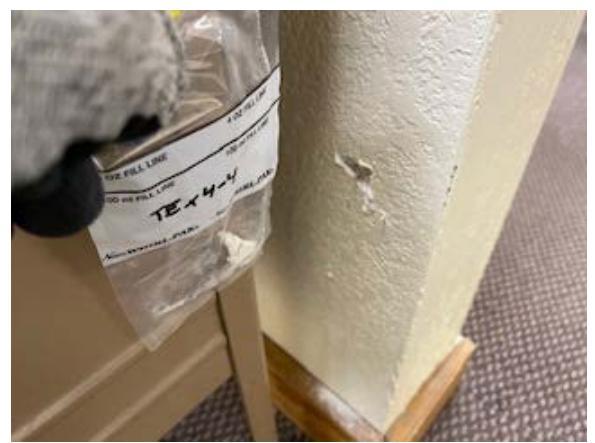
Sample: TEX4-4 Result: None Detected

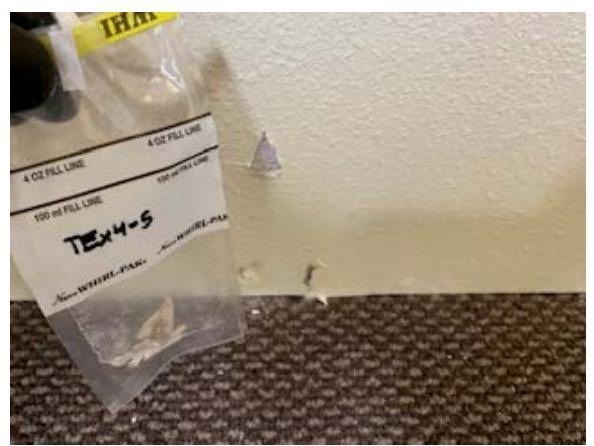
Sample: TEX4-5 Result: None Detected

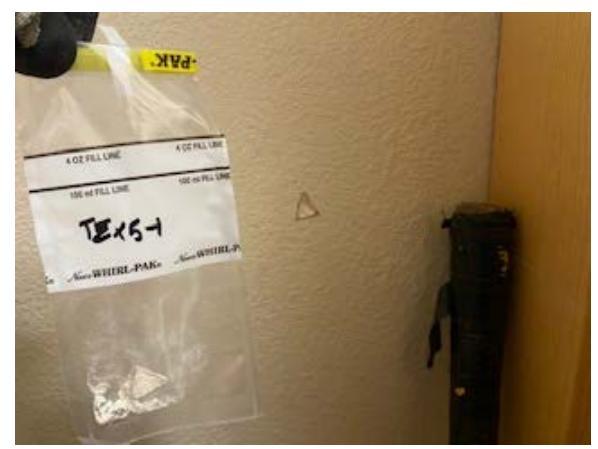
Sample: TEX5-1 Result: None Detected

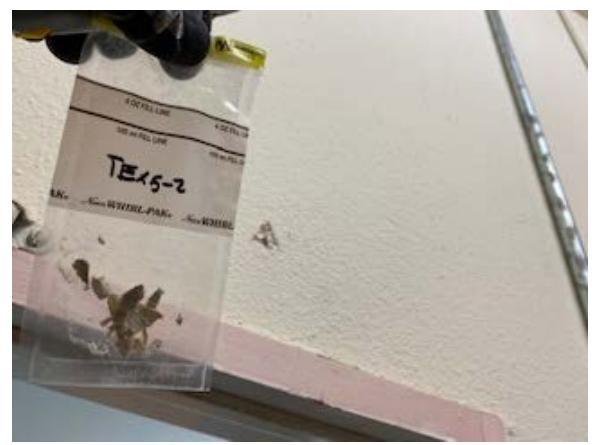
Sample: TEX5-2 Result: None Detected

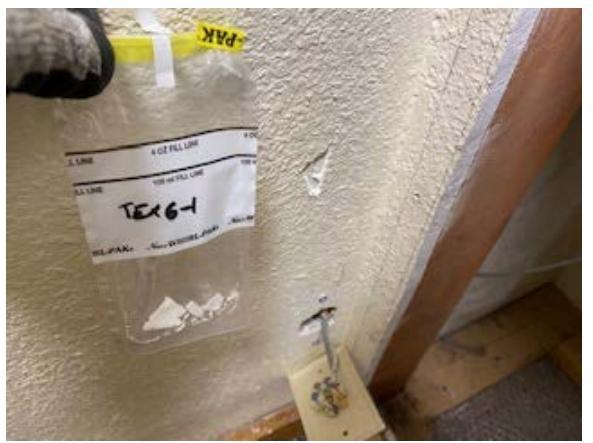
Sample: TEX6-1 Result: None Detected

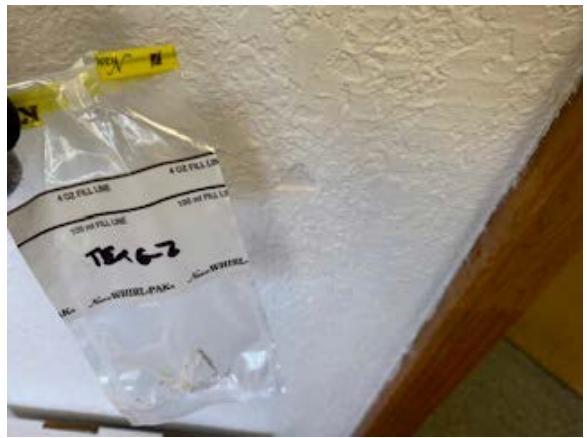
Sample: TEX6-2 Result: None Detected

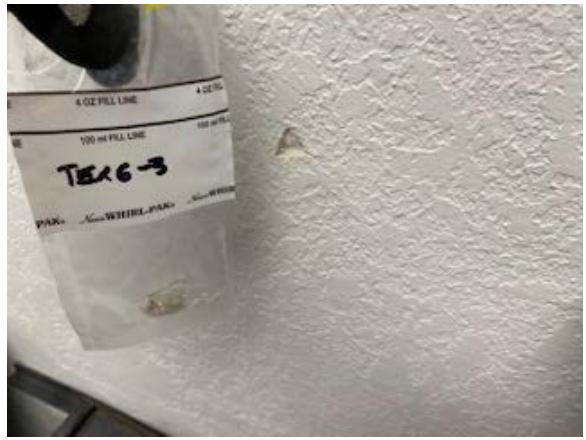
Sample: TEX6-3 Result: None Detected

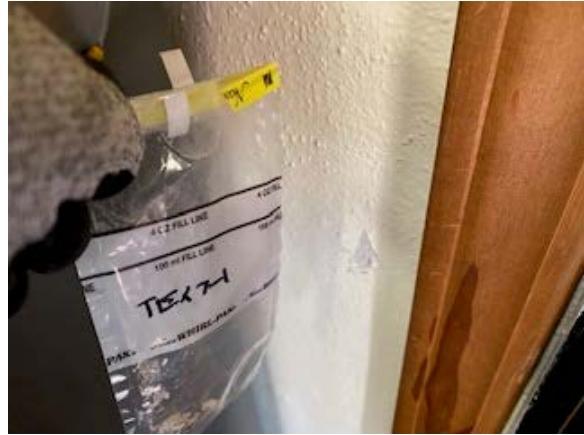
Sample: TEX7-1 Result: None Detected

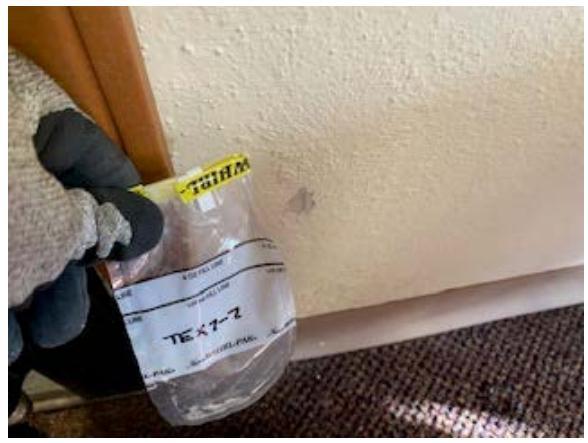
Sample: TEX7-2 Result: None Detected

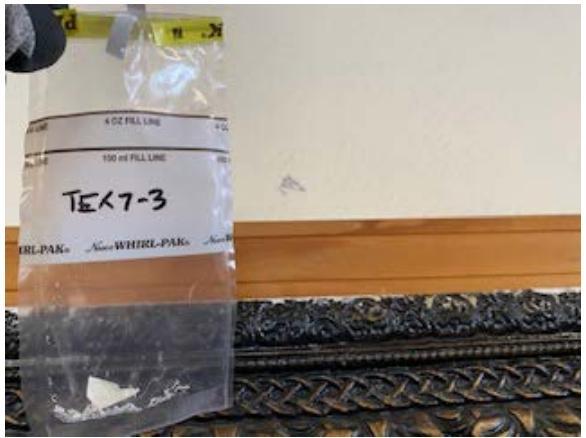
Sample: TEX7-3 Result: None Detected

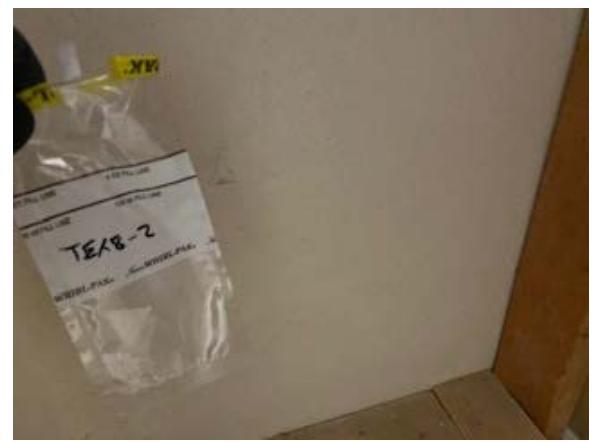
Sample: TEX8-2 Result: None Detected

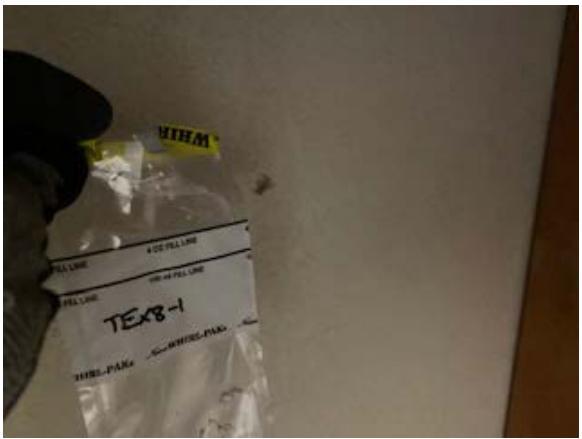
Sample: TEX8-1 Result: None Detected

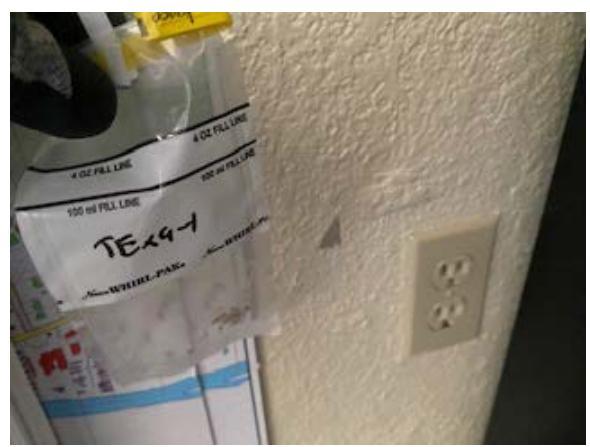
Sample: TEX9-1 Result: None Detected

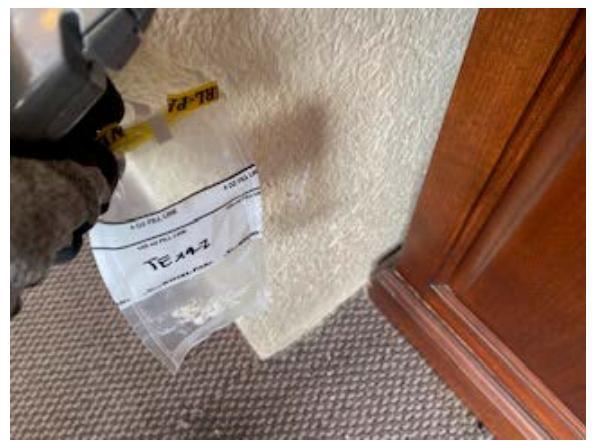
Sample: TEX9-2 Result: None Detected

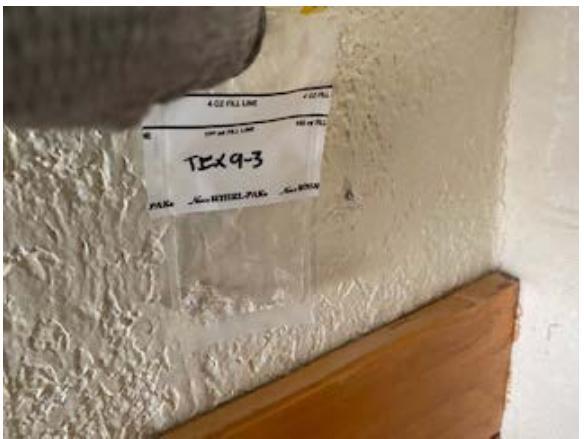
Sample: TEX9-3 Result: None Detected

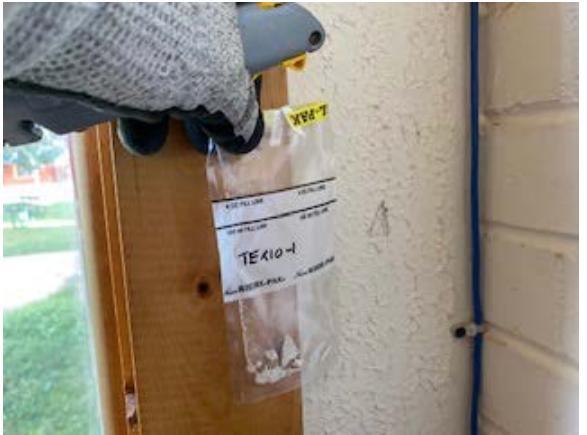
Sample: TEX10-1 Result: None Detected

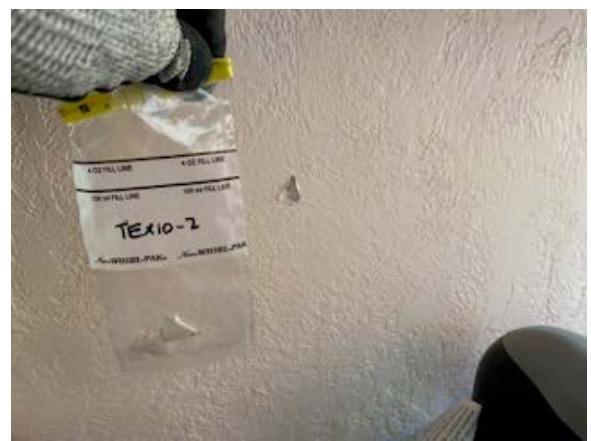
Sample: TEX10-2 Result: None Detected

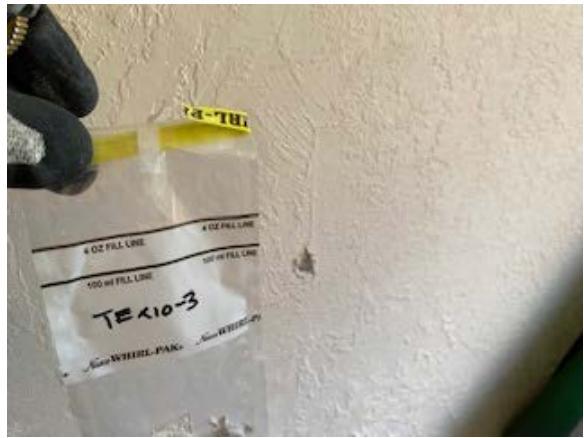
Sample: TEX10-3 Result: None Detected

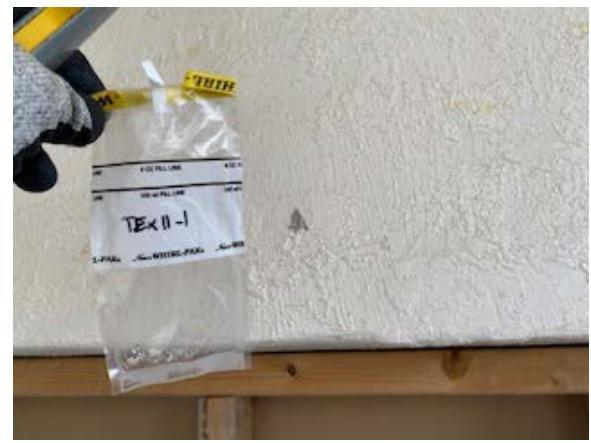
Sample: TEX11-1 Result: None Detected

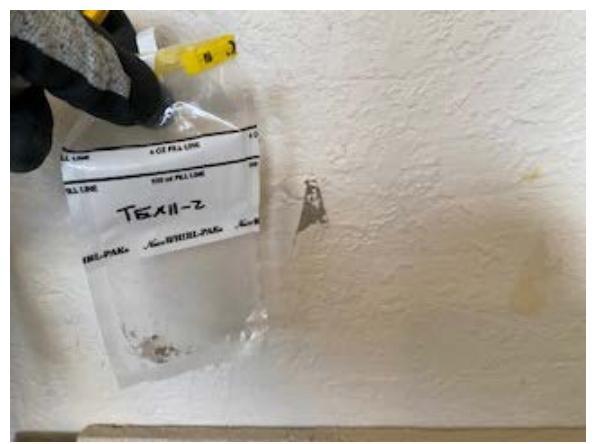
Sample: TEX11-2 Result: None Detected

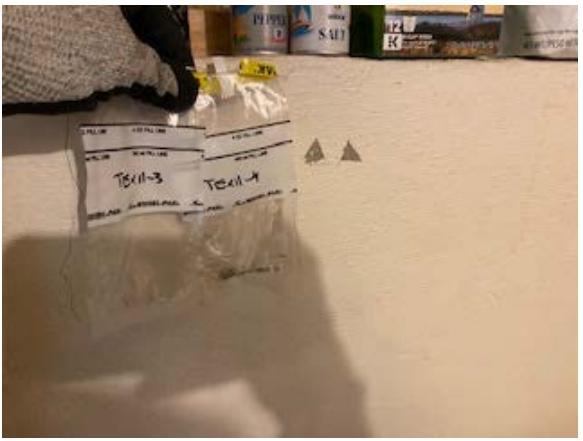
Sample: TEX11-3/4 Result: None Detected

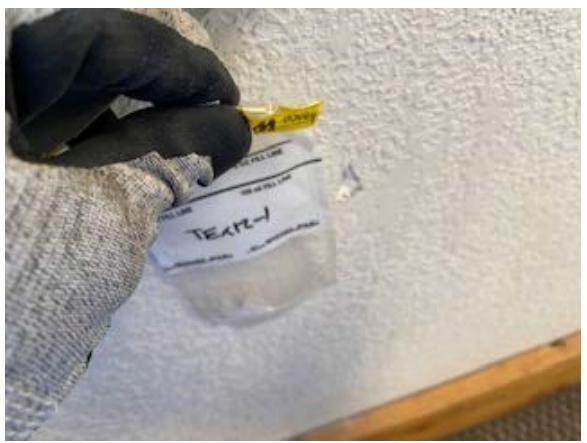
Sample: TEX12-1 Result: None Detected
