ASBESTOS INSPECTION REPORT

Project Location: Delores Town Hall Building 420 Central Avenue Dolores, Colorado 81323

> September 29, 2023 Project No. AS23127

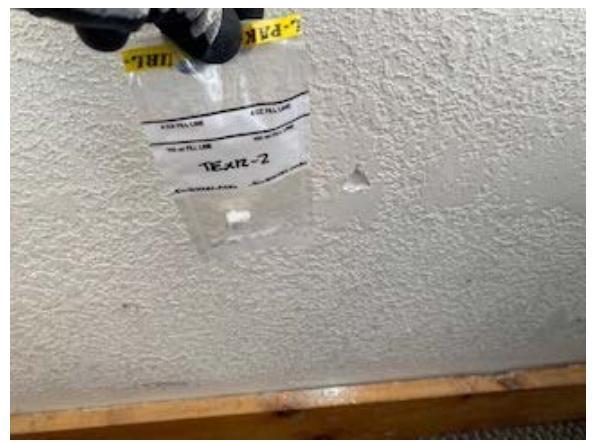
Sample: TEX12-2 Result: None Detected

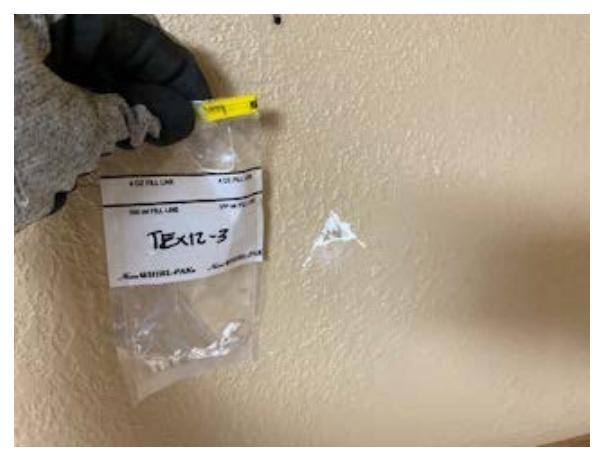
Sample: TEX12-3 Result: None Detected

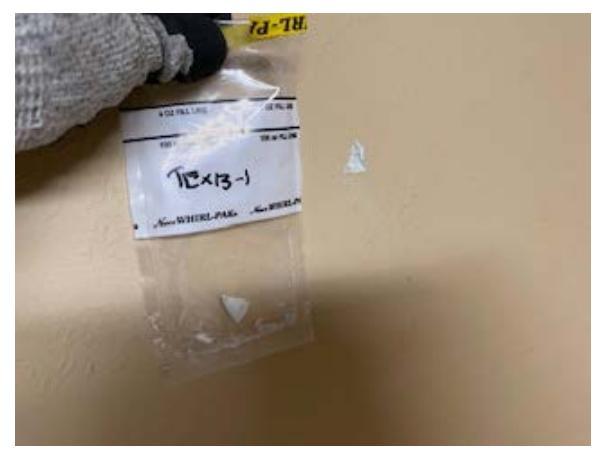
Sample: TEX13-1 Result: None Detected

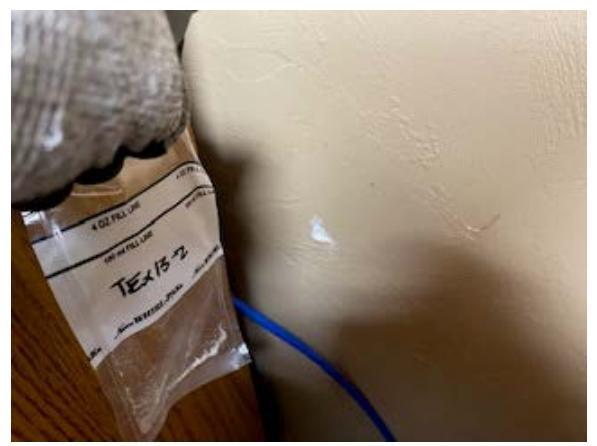
Sample: TEX13-2 Result: None Detected

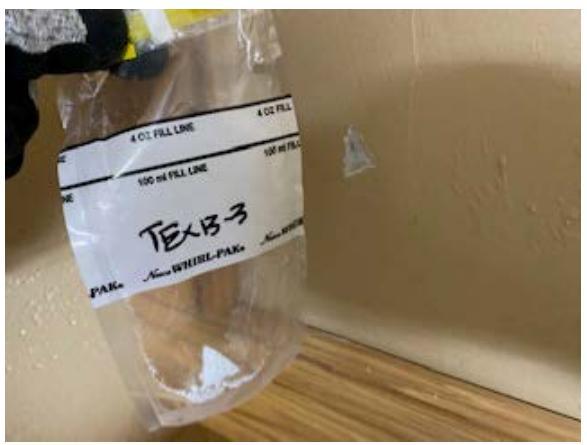
Sample: TEX13-3 Result: None Detected

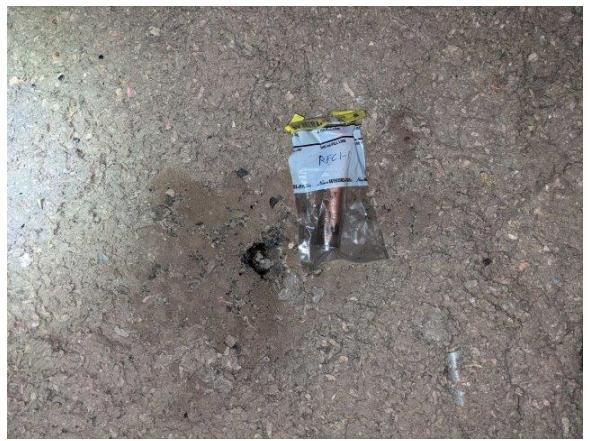
Sample: RFC1-1 Result: None Detected

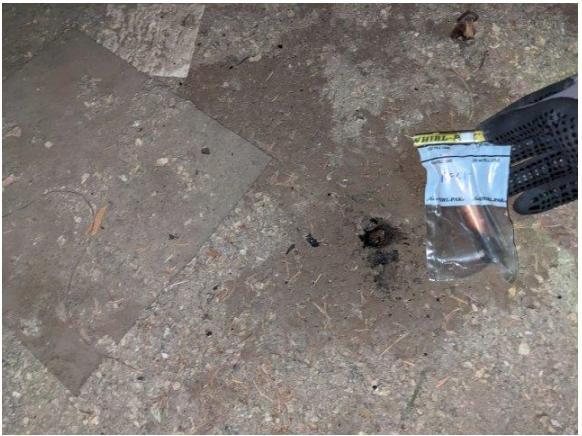
Sample: RFC1-2 Result: None Detected

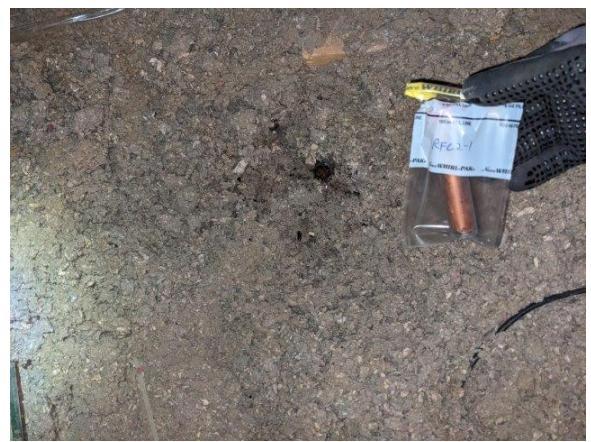
Sample: RFC2-1 Result: None Detected

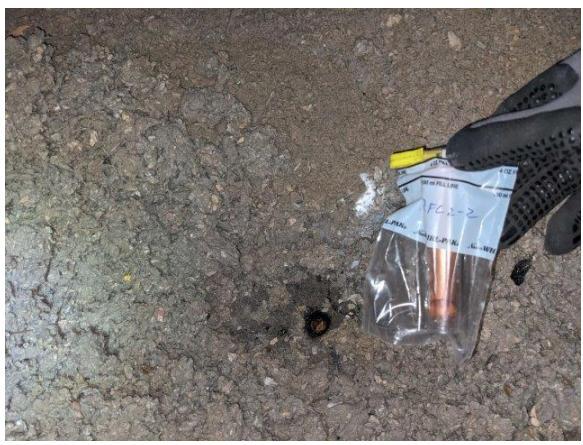
Sample: RFC2-2 Result: None Detected

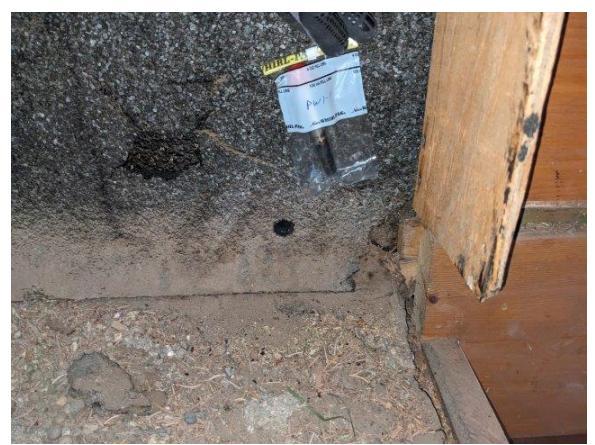
Sample: PW1-1 Result: None Detected

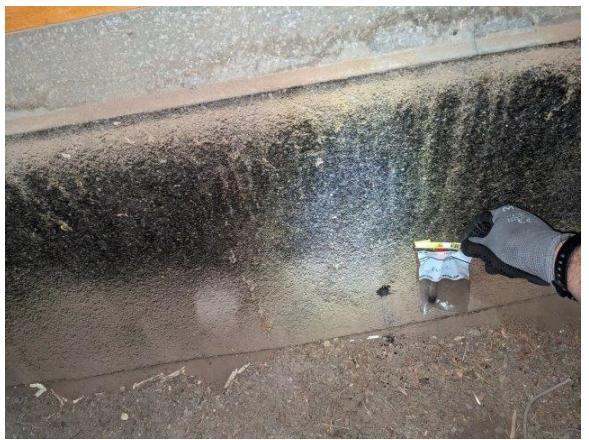
Sample: PW1-2 Result: 18% Chrysotile in black fibrous tar

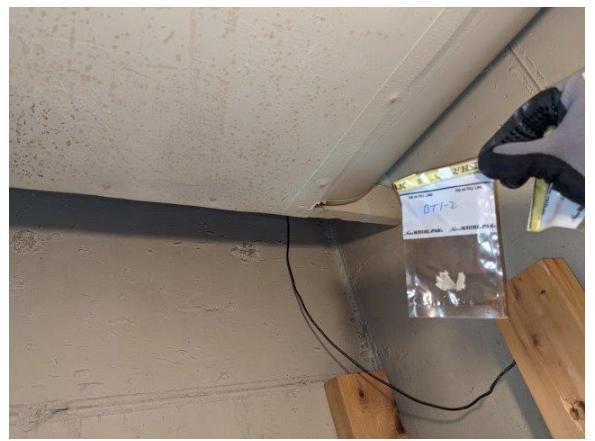
Sample: DT1-2 Result: 55% Chrysotile

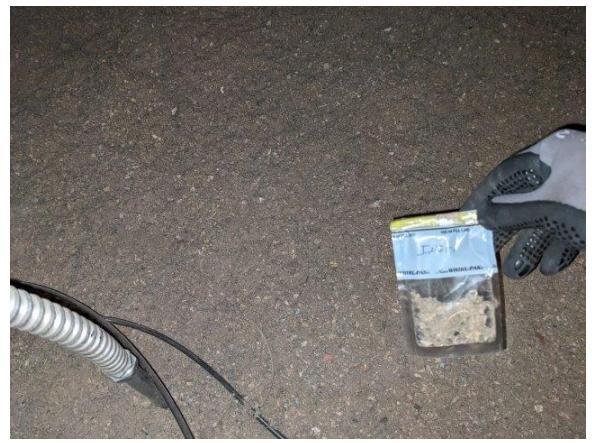
Sample: INS1-1 Result: None Detected

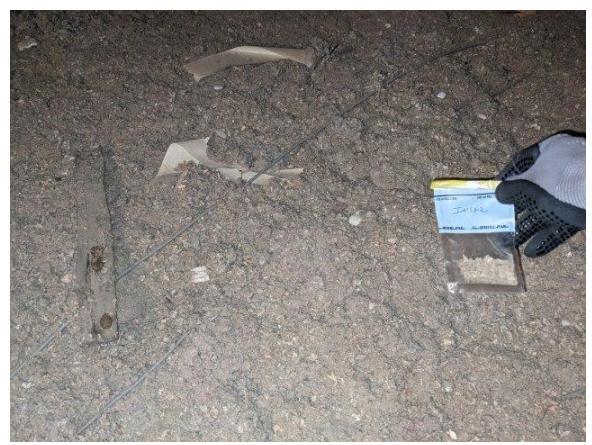
Sample: INS1-2 Result: None Detected

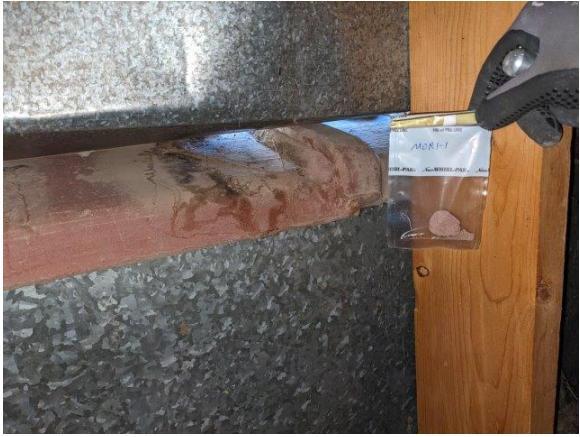
Sample: MOR1-1 Result: None Detected

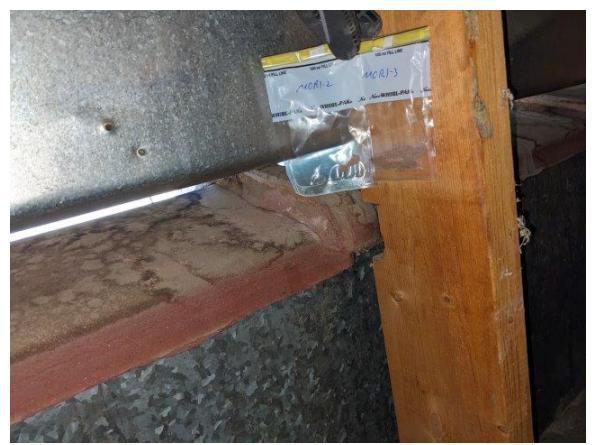
Sample: MOR1-2/3 Result: None Detected

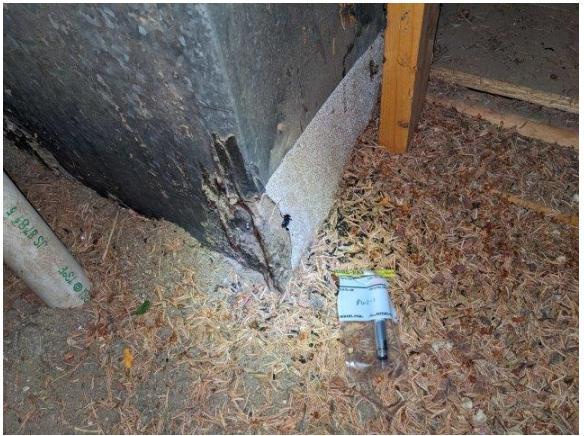
Sample: PW2-1 Result: 20% Chrysotile in black tar

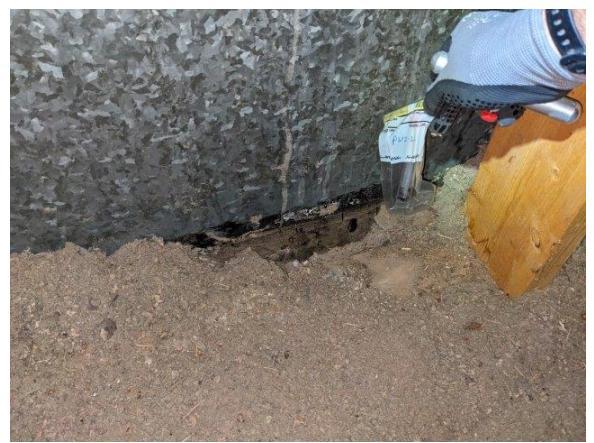
Sample: PW2-2 Result: 15% Chrysotile in black tar

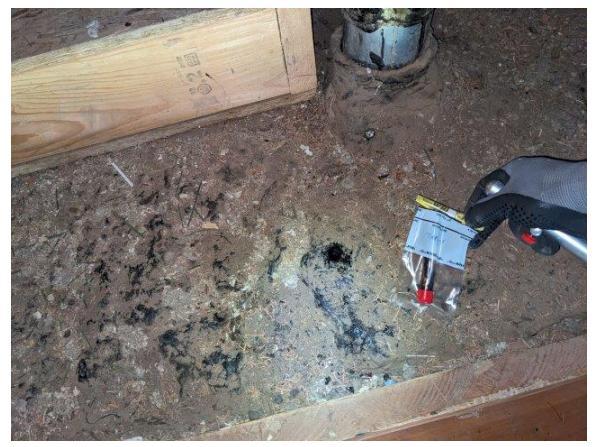
Sample: TAR2-1 Result: None Detected

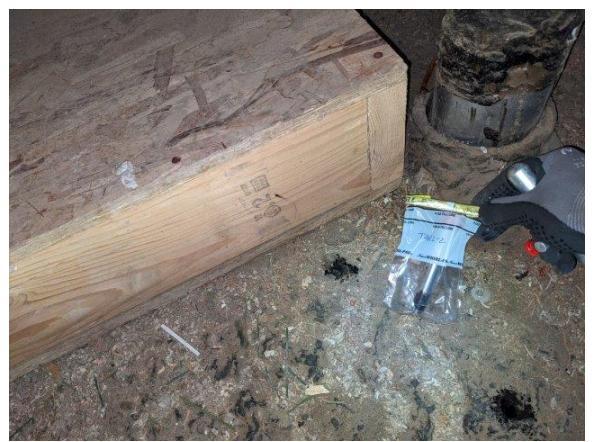
Sample: TAR2-2 Result: None Detected

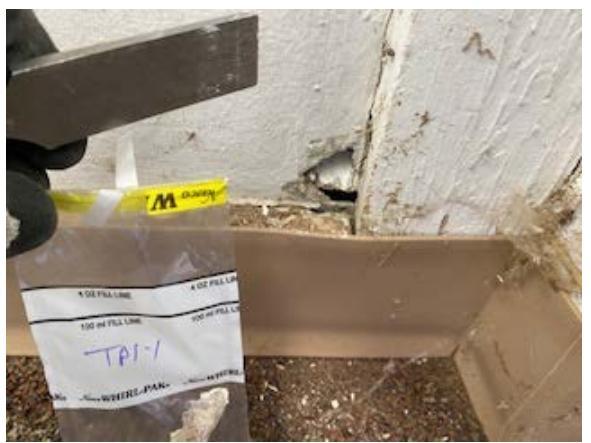
Sample: TP1-1 Result: 20% Chrysotile

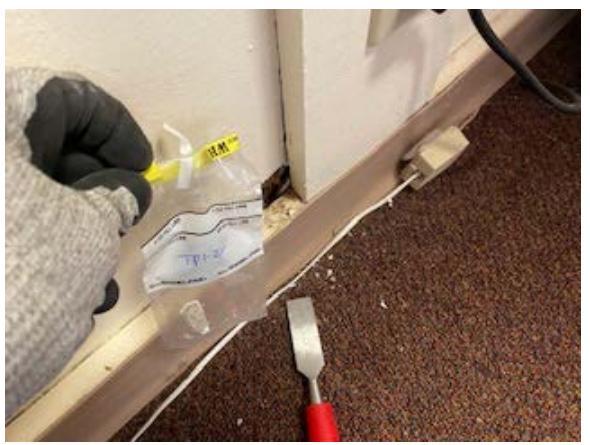
Sample: TP1-2 Result: 20% Chrysotile

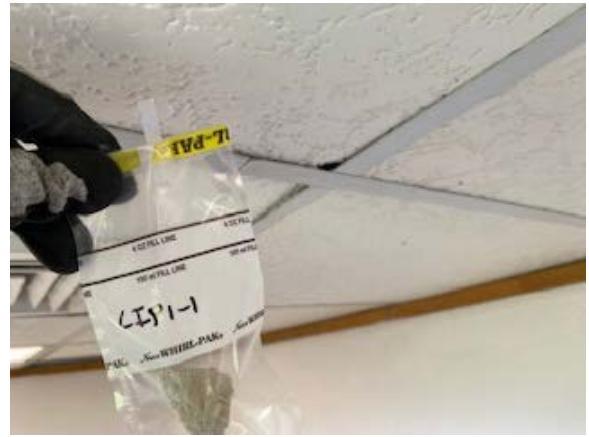
Sample: LIP1-1 Result: None Detected

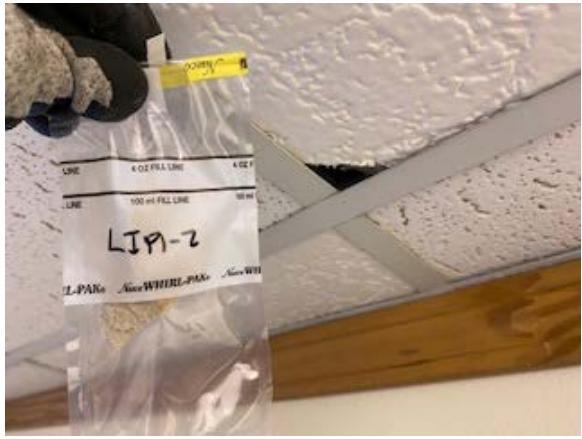
Sample: LIP1-2 Result: None Detected

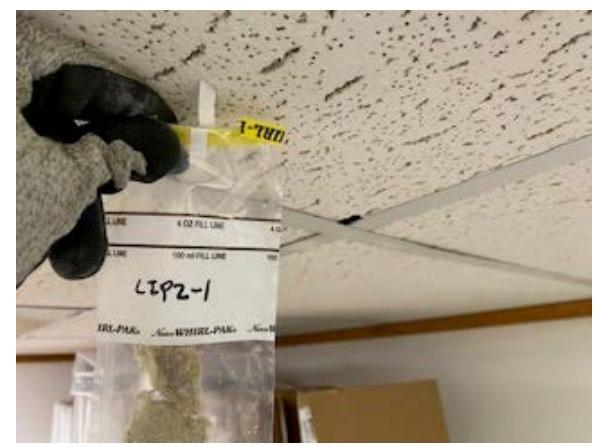
Sample: LIP2-1 Result: None Detected

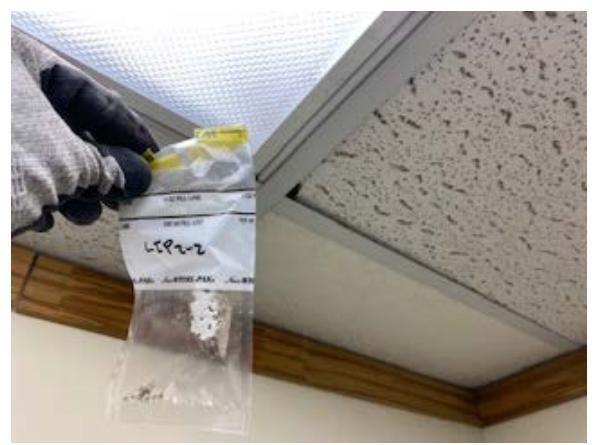
Sample: LIP2-2 Result: None Detected

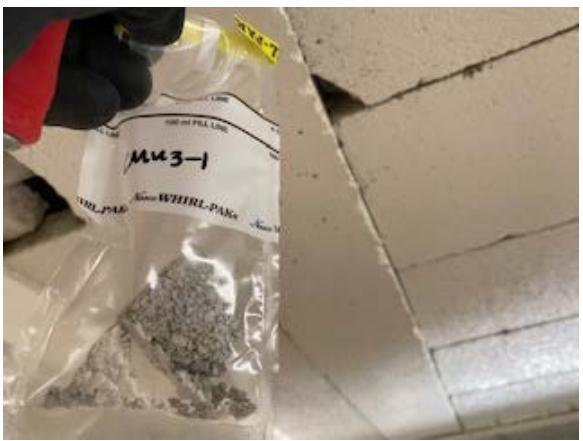
Sample: CMU3-1 Result: None Detected

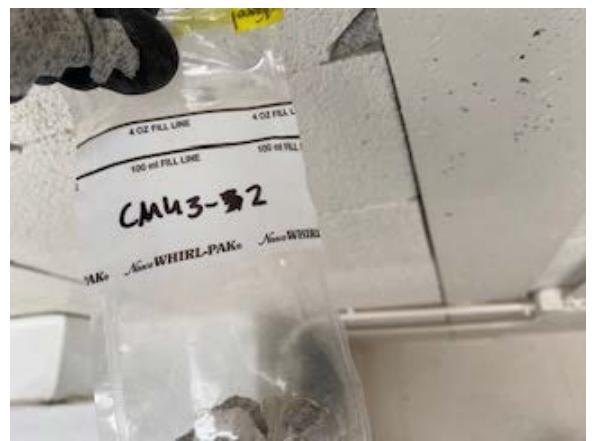
Sample: CMU3-2 Result: None Detected

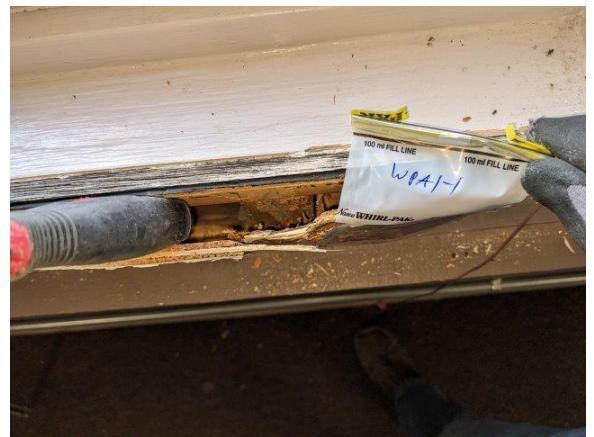
Sample: WPA1-1 Result: None Detected

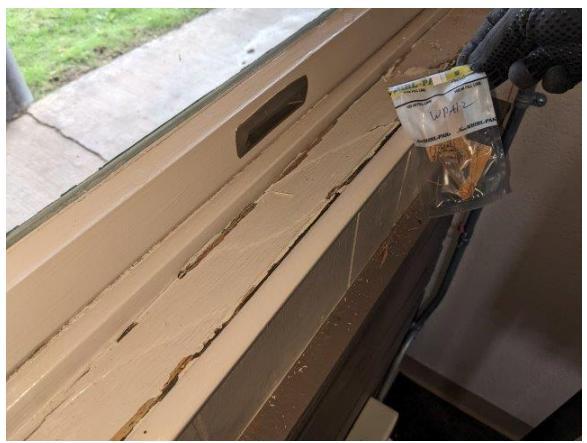
Sample: WPA1-2 Result: None Detected

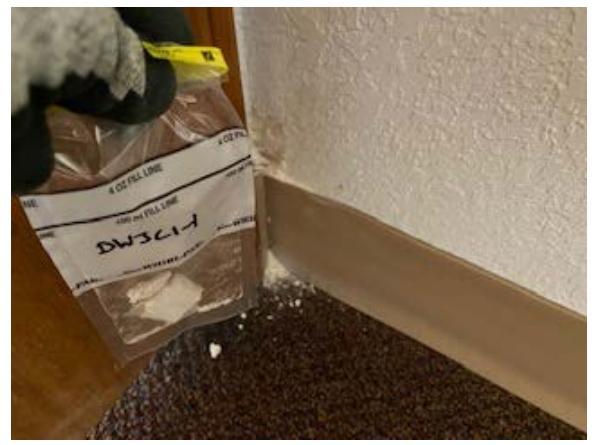
Sample: DWJC1-1 Result: None Detected

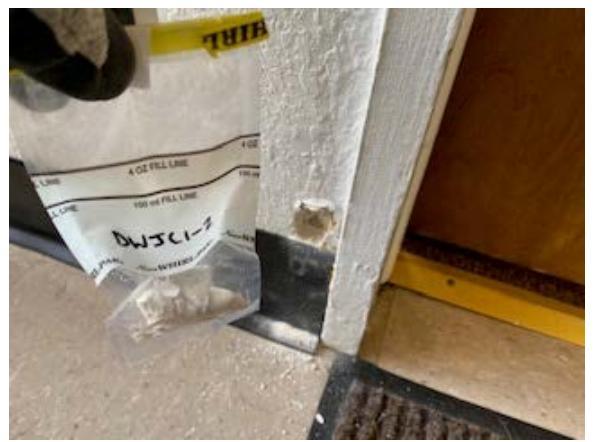
Sample: DWJC1-2 Result: None Detected

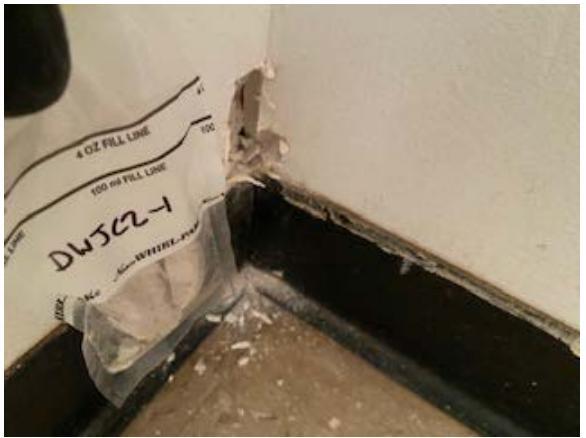
Sample: DWJC2-1 Result: None Detected

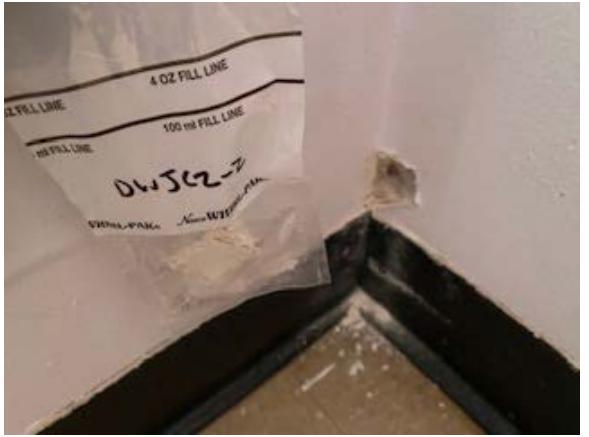
Sample: DWJC2-2 Result: None Detected

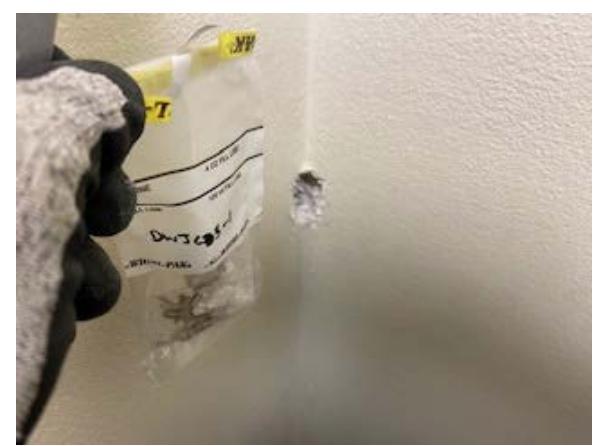
Sample: DWJC3-1 Result: None Detected

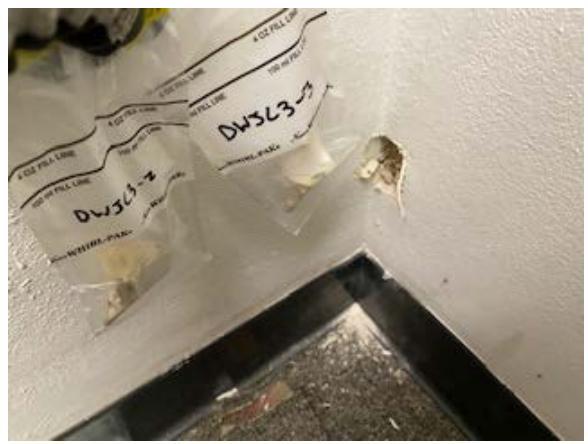
Sample: DWJC3-2/3 Result: None Detected

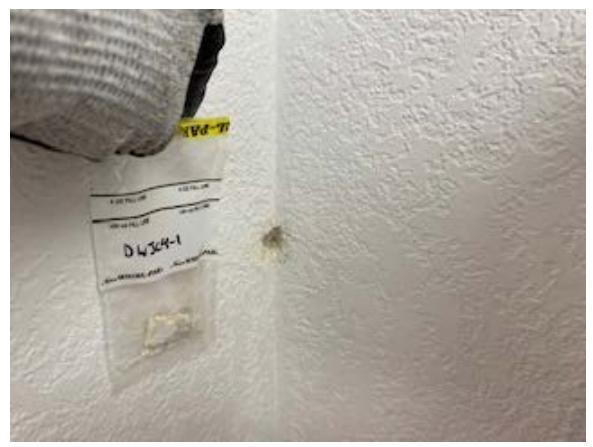
Sample: DWJC4-1 Result: None Detected

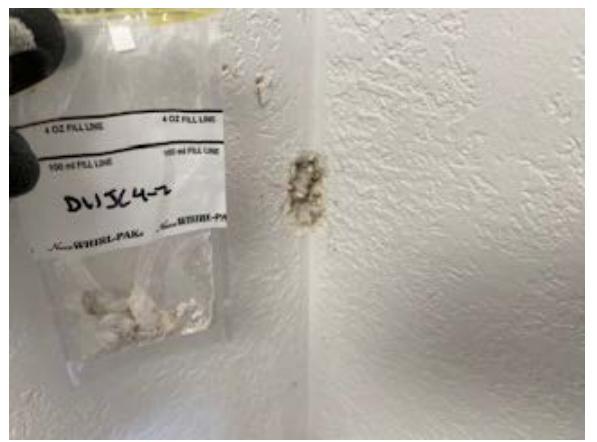
Sample: DWJC4-2 Result: None Detected

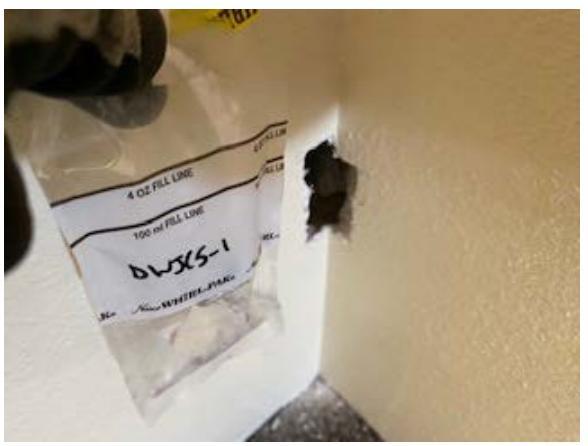
Sample: DWJC5-1 Result: None Detected

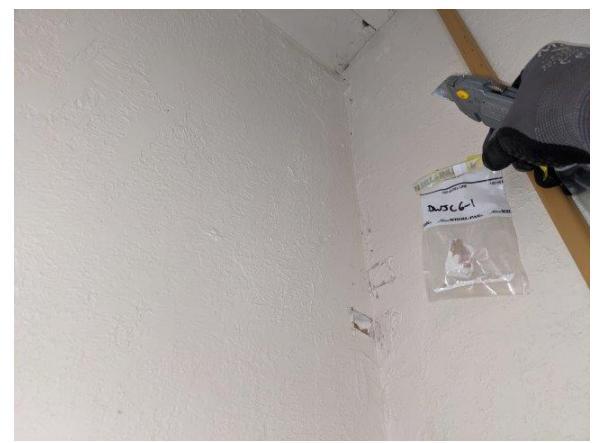
Sample: DWJC6-1 Result: None Detected

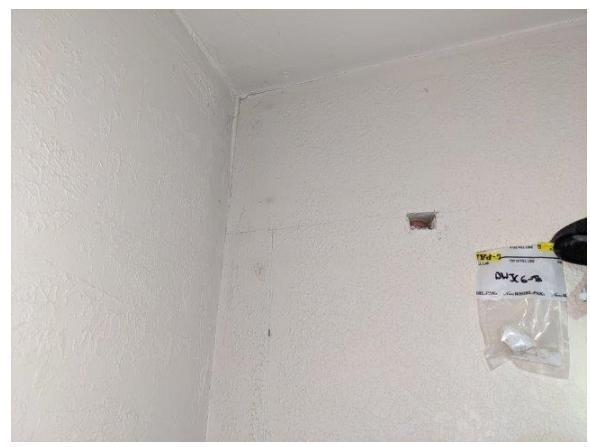
Sample: DWJC6-2 Result: None Detected

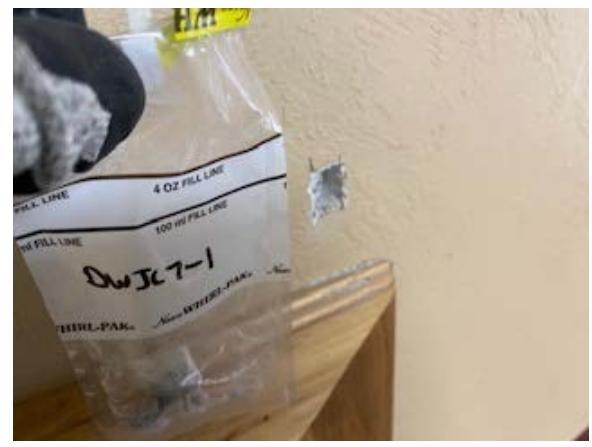
Sample: DWJC7-1 Result: None Detected

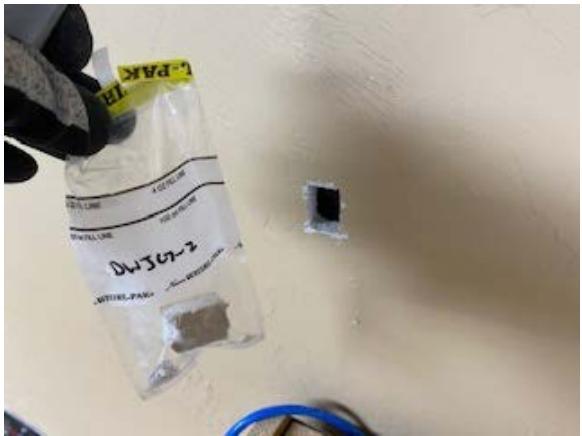
Sample: DWJC7-2 Result: None Detected

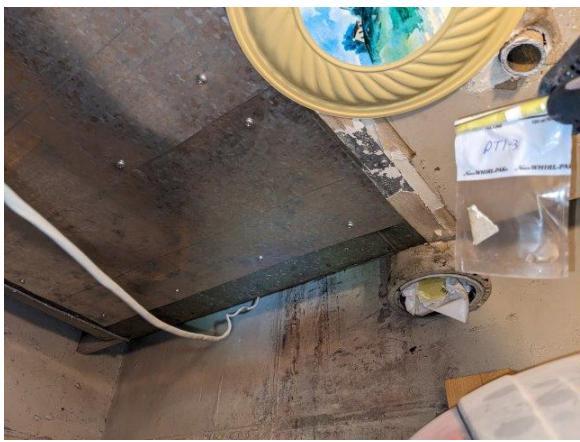
Sample: PC1-1 Result: None Detected

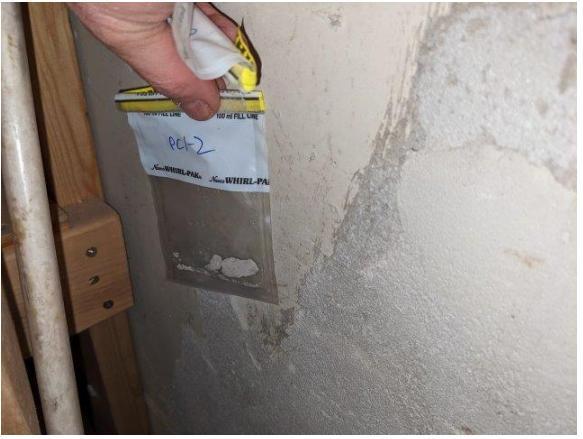
Sample: PC1-2 Result: None Detected
